Diagnosis of MV Oil Filled Cable Terminations with X-Ray Imaging and Infrared (IR) Thermography

¹Mohd Rafi Adzman, ¹Ismail Daut, ¹Muzamir Isa, ¹Baharuddin Ismail, ¹Omar Aliman
²Matti Lehtonen and ²Petri Hyvonen²
¹School of Electrical System Engineering, KUKUM Malaysia
²Laboratory of Power System, TKK Finland

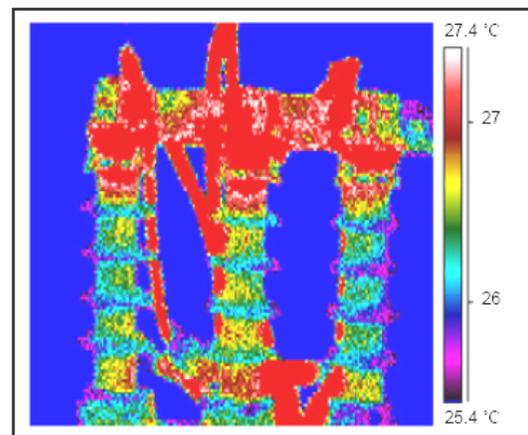
Fig. 4: Thermal images of porcelain type of cable termination subjected at 200A, 50Hz for 120 min.

It can be seen that the middle porcelain termination having most of the area with yellowiest color compared with the other two terminations. Red color can be seen at the lower and upper part of the middle porcelain termination. Based on IR thermal image results, we can know that the middle porcelain termination having higher temperature than the other two terminations.

The unsatisfactory part from this experiment, we could not see any separator mark of oil level showing a temperature difference between two levels for instant upper and lower part of termination.

Most probably, this kind of fault can only be seen by using a high sensitivity and resolution infrared thermography camera. The experiments also focus on porcelain type of cable termination. Further investigation using IR camera measurements should be made to other type of oil filled cable termination such as rubber tube type of cable termination. The diagnosis results are expected to be different due to different material properties of the termination.

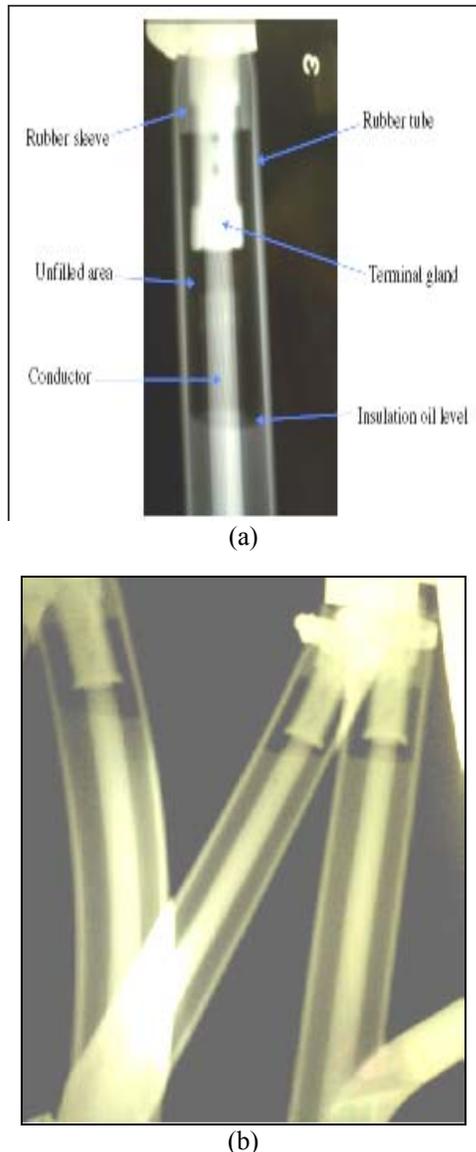
Fig. 5a and b: X-ray image on the upper side of rubber tube type of termination

X-ray imaging: The X-ray image of rubber tube cable termination was taken at several existing substations in Finland. From the X-ray image as shown in Fig. 5b, it can clearly be seen that the oil is always in horizontal position, even though the cable termination posture was not in vertical position. The X-ray image shows that the insulation oil inside the rubber tube type of termination

is at the specified mark level. Based on the X-ray image we can make a fast judgment that as long as the insulation oil inside the termination remains in full position, the termination is in good condition. Otherwise if there is some other internal defect that can cause partial discharges in the cable termination system. In case of porcelain type of termination, it required higher quantity of X-ray to produce a good image of shadows. This is because porcelain has higher density and it absorbed more X-rays than rubber.
