Environmental and Safety Accidents Related to Blasting Operation

ABSTRACT

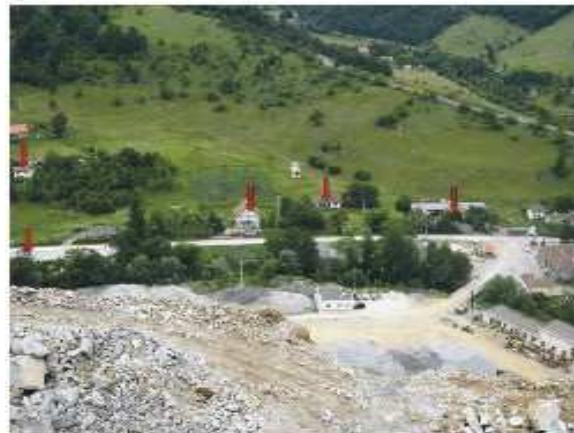
A recent environmental and safety accident occurred at an andesite quarry. Rocks up to 0.5 m in diameter were propelled almost 300 m from the center of blasting causing extensive damages to the surrounding objects. **Figure 1** shows the position of the objects that were damaged during the blasting process, while **Fig. 2** shows both external and internal damages of one of the objects struck by the flyrock. Various sizes of the rocks found at the damaged objects are given in **Fig. 3**.

Fig. 1. Position of the objects damaged by the flyrocks

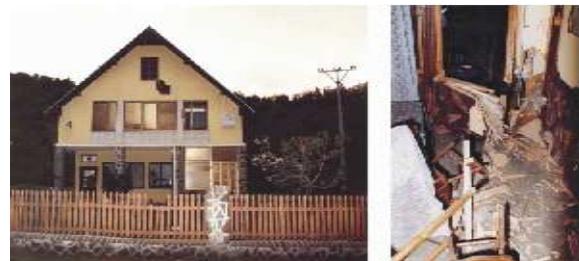
Fig. 2. External and internal view of the objects damaged by the flyrocks

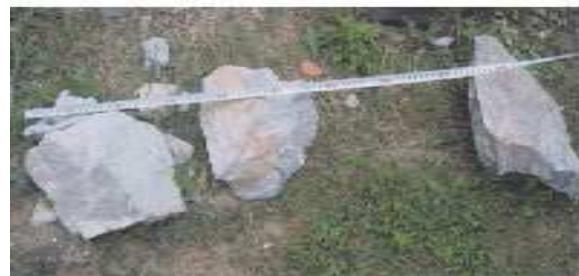
Fig. 3. Flyrocks found at the damaged objects

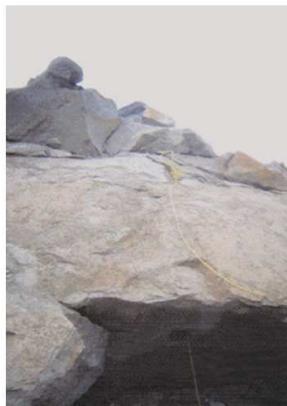
Fig. 4. Overhangs with two explosive cartridges in the stemming zone of the blastholes at the end of blasting section II

The field investigation after the accident revealed the existence of the overhangs with two explosive cartridges in the stemming zone at the end of blasting section II (**Fig. 4**). At the muckpile of blasted rocks at section II, a significant number of fragments with a high degree of andesite alteration were found (**Fig. 5**). On the bench slope of the same blasting section, the relic of fresh andesite in altered andesite mass was observed (**Fig. 6**). **Figure 7** shows unaltered andesite within alteration zone where the angle between horizontal line and the fracture filled by altered material is 45°.

In order to prevent hole overloading, it is necessary to load holes as designed using the correct charge weight. Additionally, a blast ratio should be ensured sufficiently high to eliminate the possibility of excessive charging and holes have to be monitored to check the rise of the powder. In the case of reduced burden, more intermediate stemming should be applied. The efficiency of stemming will mostly depend upon its length (Kricak *et al.*, 1996). In general, the stemming

length should be not less than 25 times the blast hole diameter (Sheridan, 2002). Konya and Walter (1990) recommend a stemming length of 0.7 times the burden. If there are fractured rocks in the collar zone of the hole, they must be removed before hole initiation in order to prevent cratering. Probability of flyrock occurrence can also be reduced by hole initiation from the bottom rather than from the top.

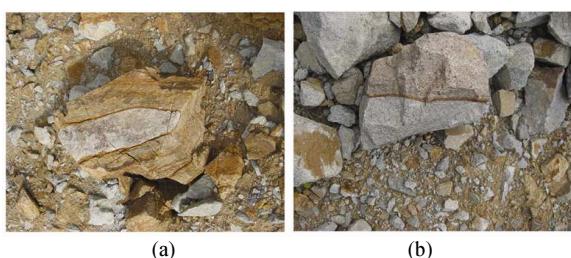
Fig. 5. Fresh andesite within alteration zone (a) and partial alteration of andesite (b)

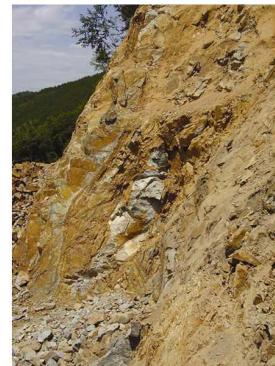
Fig. 6. The relic of fresh andesite in altered andesite mass at the bench slope

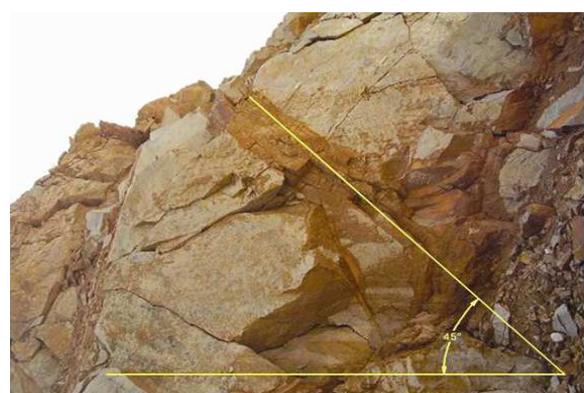
Fig. 7. Unaltered andesite within alteration zone

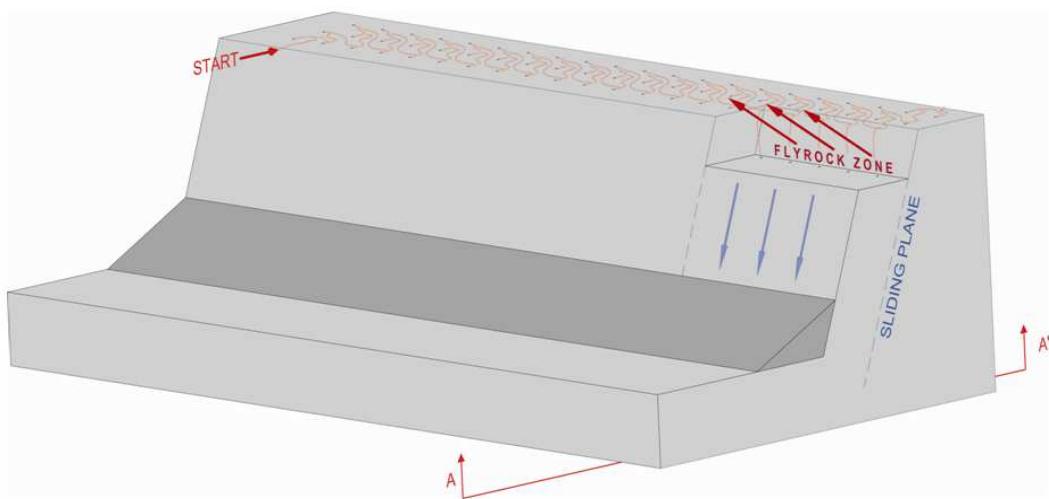
Based on the previous field observation, the model of blasting section II was created (**Fig. 8. and 9**). Analyzing the model and the maximum flyrock throw distance, it was concluded that the major contributing factor to the accident was the existence of andesite alteration in blasting section II. The existence of this alteration caused a sliding of rock masses along the subsistent joint planes and thereby reduced burden for the second row of blastholes. Since the blastholes were loaded with the amount of explosives for designed value of burden, an excessive release of explosives' energy during blasting

process resulted in flyrock from the bench slope. Additionally, unloaded muckpile from previous blasting operation increased the resistance on the bottom of the blastholes and thereby forced high-pressure gases to extend upwards. Contributing factor to flyrock occurrence was also the congruence of the joint angle at the contact between unaltered and altered andesite and drilling angle, which enabled easier sliding of part of the rock masses by the existing fracture planes. One of the factors that influenced the increase of throw distance was the angle of 45 degrees between the horizontal line and the fracture filled with altered material. It is well-known from the trajectory analysis that the throw will reach the maximum value when the launch angle is 45°.

Fig. 8. Model of blasting section II

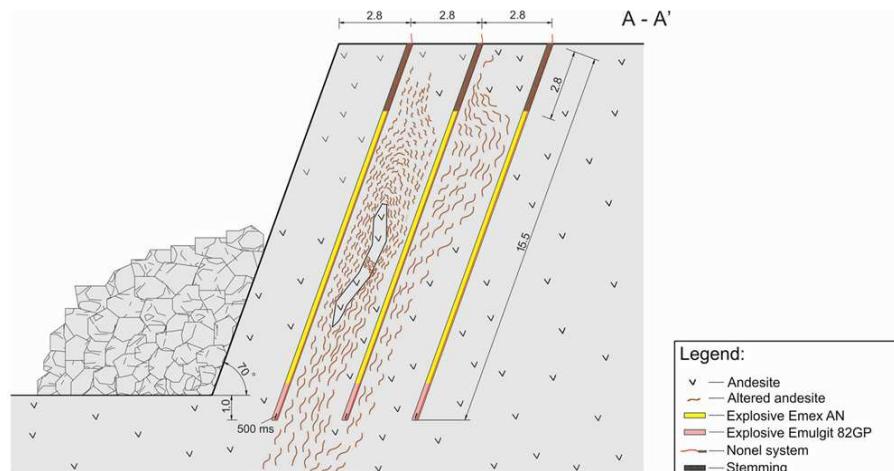
Fig. 9. A cross sectional view of blasting section II with the position of unaltered and altered andesite masses
