Vegetation Dynamics Depending on Ecological Particularities of Bozanta Mare (Maramures County-Romania) Tailing Pond: Case Study

Abstract: The present study followed an ecological demarche of reintegration in the scenery through revegetation of an anthropic ground, consisting in a waste pond formed from the flotation activity of non-ferrous ores. **Problem statement:** To support the formation of a compact vegetal layer, having anti-erosion and a restoration role, a preliminary study was required regarding the spontaneous settlement of different vegetal species. We had followed the specific floristic composition and biodiversity on the waste pond, manner of association of plant species and possible interactions with other species from the biocenosis (microorganisms and fungi). We had studied the pace at which vegetal species settle, as well as the reciprocal influence, from the point of view of vegetation, with the neighboring area, since the desideratum was the settlement of a vegetation similar to the natural one. **Approach:** The aim of the research was to draw a list of the vegetal taxa installed on the pond, as well as to detect some succession stages or some possible vegetal

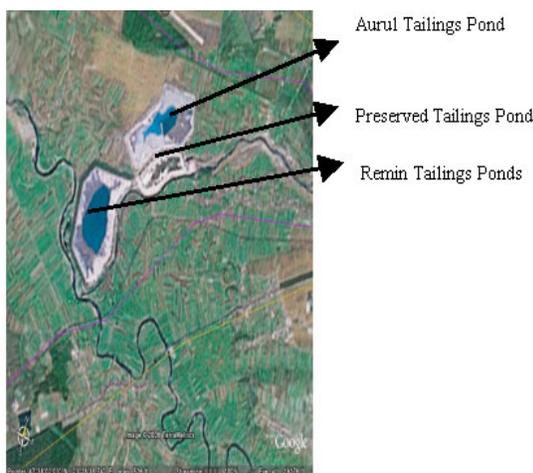
Fig. 1: Overview of tailings ponds in studied area

Study area: In Maramures County, in the hot spot areas of non-ferrous mining industry are located over 20 tailing ponds, many of them still active. We can notice a special situation near Baia Mare city, where, in the same area, there are three tailing ponds (Fig. 1), one of them being under preservation.

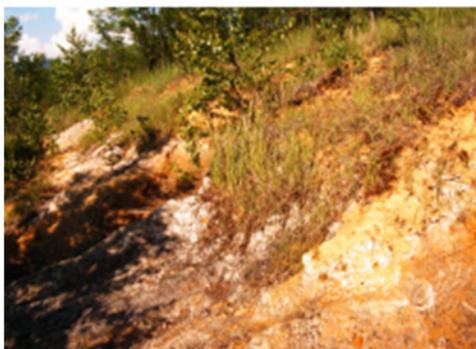
Fig. 2: Ravines in the pond's dam

Due the fact that the largest part (about 39%) of pond's dam is made by fine particles (under 0.005 mm Table 1), large amounts of fine particles in the sub-layer, strongly polluted with heavy metals, were transported by winds and deposited in the surrounding areas. Large size particles were transported by rains and thus many ravines appeared Fig. 2. This erosion process reduces the physically stability of the pond.

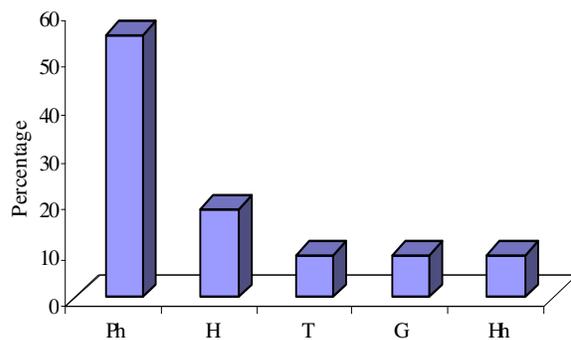
Raunkiaer's life forms analyses: The structure of Raunkiaer's life forms: Mega Phanerophytes (from a past forestation trying) prevail with 54.54%, followed by hemicryptophytes 18.18% and the other life forms are in smaller proportions (Fig. 3).

Fig. 3: Raunkiaer's life forms: PhM mega phanerophytes, Phm meso-phanerophytes, Phn nano phanerophytes, H-hemicryptophytes, G-geophytes, Hh-helohydatophytes, ch-chamephytes

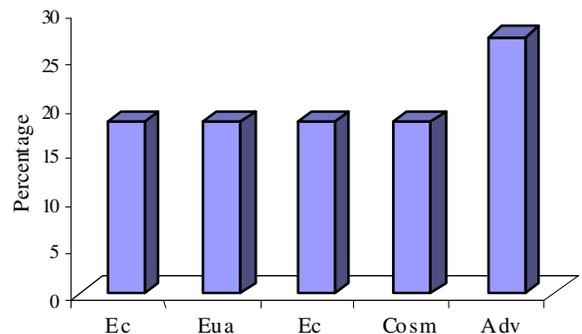
Fig. 4: Floristic elements spectrum

In the floristic elements spectrum, prevail the Adventive species (27.27%), followed by the cosmopolite species and the eurasiatic species, central European species, circumpolar species and cosmopolites. The diploidy index (DI = D/P×100) has a value of 37.5%.

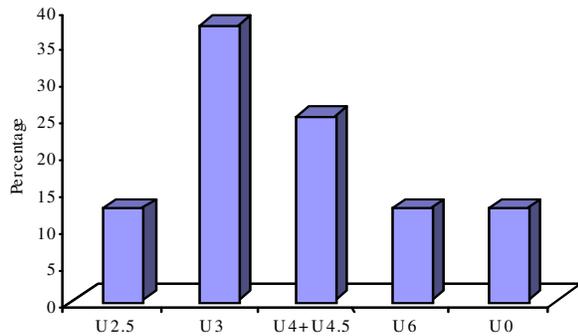
Fig. 5: Humidity indices spectrum

Humidity indices spectrum Fig. 5 reveals the presence and preponderance of mesophytes species (37.5%), followed by hygromesophytes (25%). The xeromesophytes (12.5%) and euryhygrous have both the same percentage.

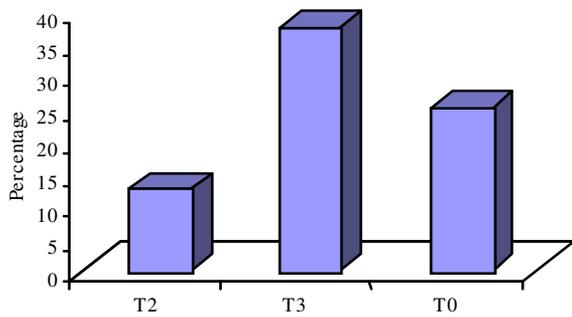
Fig. 6: Temperature indices spectrum

Temperature indices spectrum Fig. 6 demonstrates the prevalence of mesothermophilous (37.5%), followed by eurythermic (25%) species and microthermophilous species (12.5%).

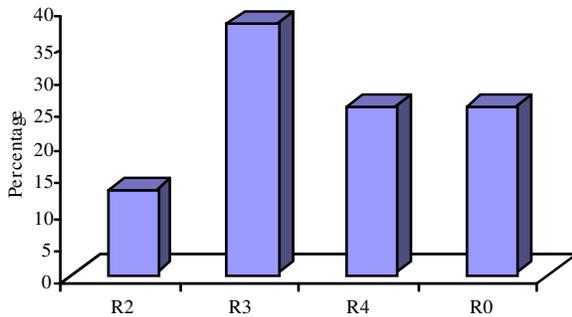
Fig. 7: Soil pH spectrum

Soil pH spectrum (Fig. 7) reveals the most of cormophytes species indentified on these sterile deposits tolerate varied values of this indicator.

Prevailing of the acido-neutrophilous species (37.5%), euriionics species (25%) and the low acido-neutrophilous species (25%) followed by the acidophilous species (12.5%).

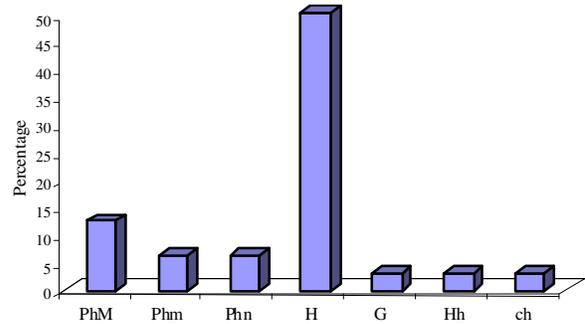
Fig. 8: Raunkiaer's life forms: PhM mega phanerophytes, Phm meso-phanerophytes, Phn-nano phanerophytes, H-hemicryptophytes, G-geophytes, Hh-helohydatophytes, ch-chamephytes

Raunkiaer's life forms analyses: The structure of Raunkiaer's life forms: Hemicryptophytes prevail with 50 and 12.5% represent Mega Phanerophytes (from a past forestation trying) and the other life forms are in smaller proportions Fig. 8. The great number of hemicryptophytes demonstrates the tendency of colonization of tailings by perennial herbaceous species.

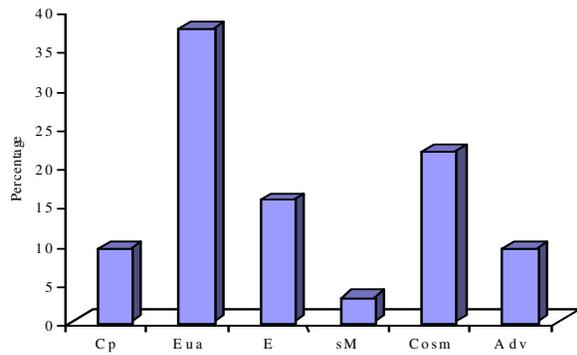
Fig. 9: Floristic elements spectrum

In the floristic elements spectrum, prevail the Eurasiatic species (37.5%), followed by the cosmopolite species (21.8%) and the alien species (9.375) (Fig. 9).

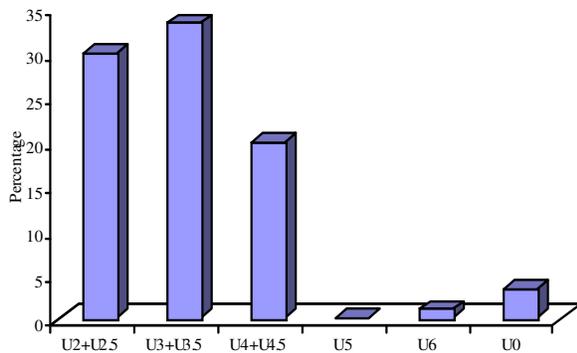
Fig. 10: Humidity indices spectrum

Humidity indices spectrum (Fig. 10) reveals the presence and preponderance of mesophytes species (33.33%) and xeromesophytes (30%), followed by mesohydrophilous (20%) and euryhygrous (3.33%).

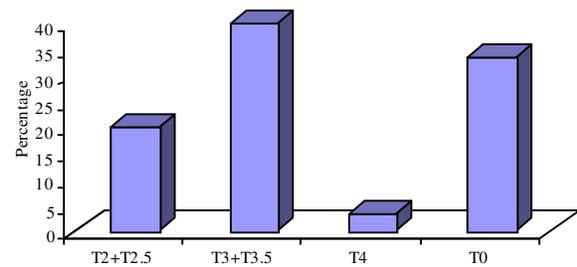
Fig. 11: Temperature indices spectrum

Temperature indices spectrum (Fig. 11) demonstrates the prevalence of mesothermophilous (36.66%), followed by eurythermic (33.33%) species and microthermophilous species (16.66%).

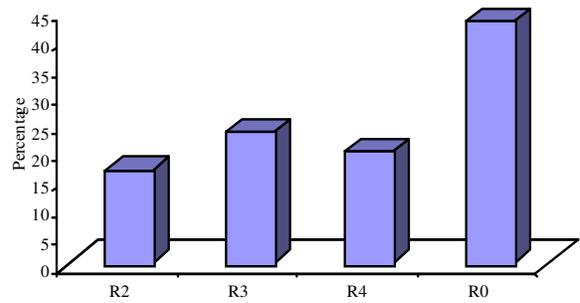
Fig. 12: Soil pH spectrum

Soil pH spectrum (Fig. 12) reveals that most of cormophytes species indentified on these sterile deposits tolerate varied values of this indicator.

Euriionics species prevail (43.33%) and the acido-neutrophilous species have a significant proportion (23.43%), followed by the low acido-neutrophilous species (20%) and by the acidophilous species (16.66%).

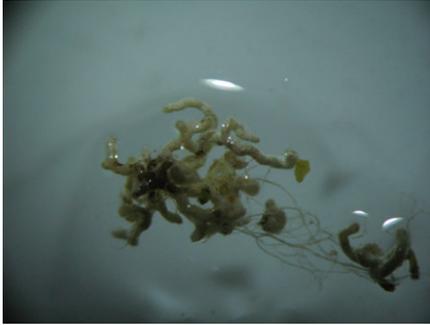
Fig. 13. Mycorrhizal roots of *Quercus petraea*

The large number of species of mycorrhizal fungi identified on the pond indicate a maintenance of ligneous vegetation. There have also been noticed mycorrhizals at the root level of *Betula verrucosa*, *Populus tremula*, *Quercus petraea* (Fig. 13).
