## River Embankment and Bank Failure: A Study on Geotechnical Characteristics and Stability Analysis

Md. Bellal Hossain, Toshinori Sakai and Md. Zakaria Hossain  
Department of Environmental Science and Technology,  
Graduate School of Bioresources, Mie University, 514-8507,  
Tsu shi, Kurimamachiyacho 1577, Mie, Japan

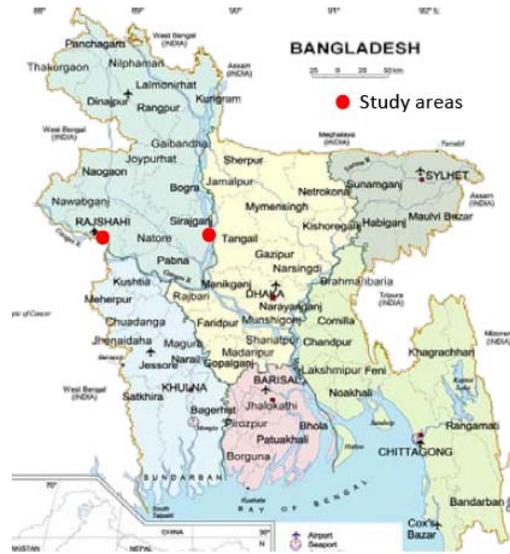
Fig. 1: Study Areas

The soil samples were collected from the broken part of the right bank embankment of Jamuna river (Fig. 1) in Shirajganj district and from the eroded bank of Padma River located in Rajshahi district. The laboratory tests were conducted in the Laboratory of Mie University. The testing procedures were in accordance with Japanese Industrial Standard (JIS) and Japanese Geotechnical Standard (JGS). The tests include particle size analysis (JIS A 1204), particle density (JIS A 1202), liquid limit and plastic limit (JIS A1205), compaction characteristics (JIS A 1210), consolidation, permeability (JIS A 1218), direct shear test (JGS 0560 and 0561) and unconfined compressive strength tests (JIS A 1216). On the basis of the test results, the soil was also classified by JGS engineering classification. The falling head method was followed to determine the coefficient of permeability. The unconfined compressive strength test was done with samples having different water content.

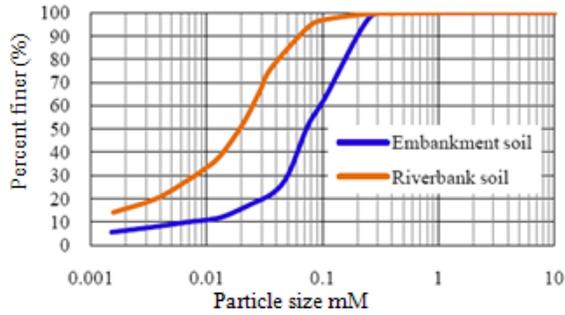
Fig. 2: Particle size distribution curves

**Physical properties:** The parameters of basic physical properties are shown in Table 1. The significant difference is found between the plastic and liquid limits of soils. Plastic limit of embankment soil refers to non plastic (NP) where that of riverbank soil is 27%. From grain size distribution analysis, maximum grain size and effective size (D10) of embankment soil were 425 and 7.6 μm respectively (Fig. 2).

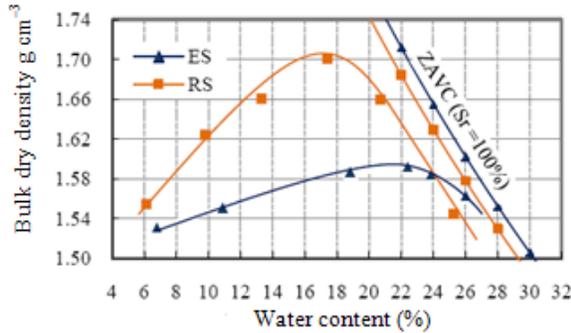
Fig. 3: Compaction curves of ES and RS

**Geotechnical properties:** From compaction tests result, the maximum dry densities of embankment soil (ES) and Riverbank Soil (RS) are found 1.59g/cm<sup>3</sup> and 1.72gm/cm<sup>3</sup> at optimum water content (wopt) of 21.2% and 16.5%, respectively (Fig. 3). The changes in permeability and strength values of ES with the increase of water content are plotted in Fig. 4. The minimum value of permeability coefficient is calculated as 1.29×10<sup>-5</sup>cm/s at 24% water content which is beyond the optimum water content and near to liquid limit (w = 25.8%). The change in the coefficient of permeability was observed almost one order larger value from the smallest coefficient of permeability for unit change of water content on dry side.

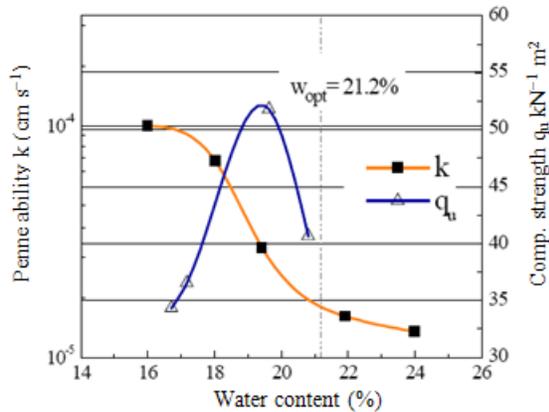
Fig. 4: Permeability and strength of embankment soil with water content

It is also predicted that the permeability is increased rapidly in submerge condition of the soil. From uniaxial compression test, the maximum value of compressive strength ( $q_u$ ) was reported as 51.8kPa at 19.6% water content which is below the optimum water level. It was also clear that the uniaxial compressive strength of the soil largely varied with the small change in water content.

So, the embankment constructed with this material needs lot of care to control water content and the strength level. As embankment material; it has got a very low strength and thus, very vulnerable to slope failure and erosion process. Hence, the slope surface needs to be protected from erosion caused by the rainfall, run off and the strong wave during high flow of river. However, the slope of the embankment of Jamuna river is found not well protected. In some places of the embankment, sandbags have been used but not worked well due to inefficient placement and lack of maintenance (Fig. 5).

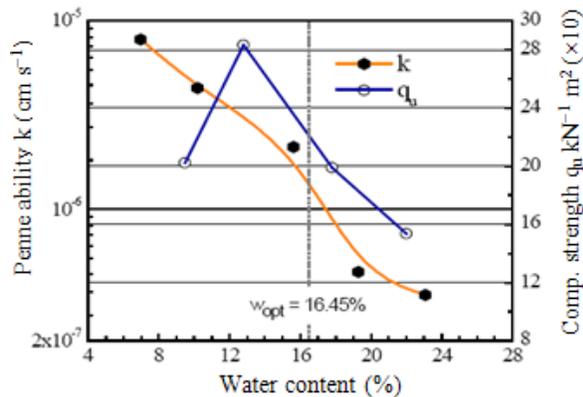
Fig. 6: Change of strength and permeability with water content of riverbank soil

The effect of water content on the geotechnical properties of riverbank soil is shown Fig. 6. The value of permeability is found to be  $3.5 \times 10^{-7} \text{cm/s}$  at over 90% saturation. From direct shear test, the shear strength parameters, cohesion ( $c$ ) and internal frictional angle ( $\phi$ ) were obtained as 153kPa and  $22^\circ$ , respectively.

The maximum compressive strength was found to be 280kPa at 12.8% water content which is below the optimum water content (16.45%). But, the strength decreases rapidly with the increase of water content and reaches to about 150kPa at 22% water content. It is also observed that the strength reduces 46% with the increase of water content by 10% after the peak value.

failure that includes both mechanisms such as planar failure with tension crack and toppling involving failing blocks with the same geometry. From geotechnical point of view, it is understood that the strength of bank soil decreases rapidly with the increase of water content. The permeability also becomes very low (<1×10<sup>-6</sup>cm/s) at the same time (Fig. 6) which ultimately increases the weight of material and triggers mass failure of bank.

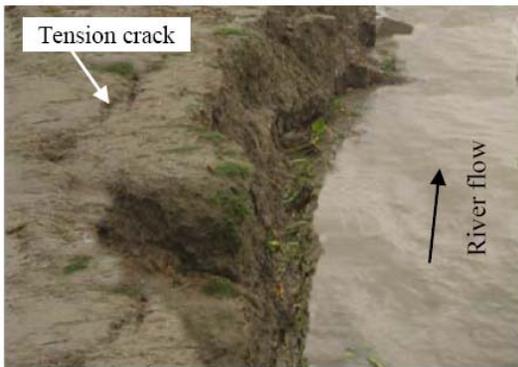
Fig. 7: Riverbank failure at charghat

**Bank failure mechanism:** The bank-failure mechanism of Padma river in the study area was identified based on the field observations, discussion with the local community and the test results of the sample materials. The failure is associated with the formation of tension cracks few feet behind the bank line (Fig. 7). It is also reported that the severe bank failure occurs during the recession of flood water when the velocity of river flow seems to be very high. This type of failure can be described as slab-type rotational

In addition, during drawdown of river water at the end of flood, groundwater level in the bank decreases at a lower rate than the level of surface water due to low permeability of the bank material. This phenomenon causes an imbalance of force of water pressure in the riverbank and the confining pressure of surface water on the slope which also causes sudden mass failure of the bank. In this circumstance, it is very much necessary to find out the limiting value of the critical bank slope and height in order to take necessary measure for the protection of riverbank in the study area. A limit equilibrium method of bank stability analysis can be followed as proposed by Darby and Thorne (1996). This is a new approach for riverbank stability analysis which can be applicable for the steep, cohesive, non-layered riverbank that fails along planar failure surface. In this method, pore-water and hydrostatic confining pressure are also included where the failure plane is not constrained to pass through the toe of the bank.

**Recommendations:** The geotechnical properties of embankment material need to be improved by using additives or reinforcing materials like soil-cement, natural or geosynthetic fiber etc. It is also necessary to protect the slope by facing materials using geo-bags, cement composites with reinforcement etc. It is also recommended to locate the free surface inside the

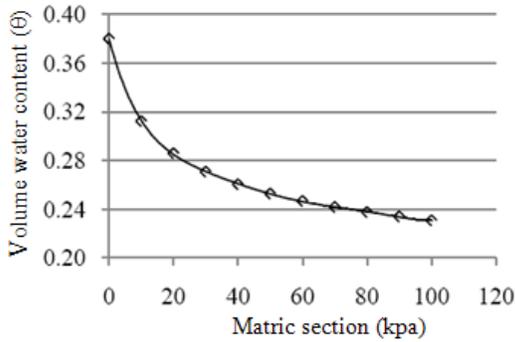
Fig. 9: Water-retention curve

These hydraulic parameters ( $k_s$ ,  $\alpha$  and  $n$ ) were predicted by using a database program ROSETTA (Schaap et al., 2001) that used soil texture data for predicting the parameter values. The soil type of Manu river embankment is sandy-clay for which the hydraulic parameters  $k_s$ ,  $\alpha$  and  $n$  were predicted as  $3.33 \times 10^{-7}$  m/s, 2.7 and 1.23 respectively. Using these hydraulic parameters the soil-water retention curve is plotted as shown in Fig. 9.
