# Infrared Thermography for the Characterization of Painted Vaults of Historic Masonry Buildings

Claudia Casapulla, Alessandra Maione and Luca Umberto Argiento

Department of Structures for Engineering and Architecture, University of Naples Federico II, Italy

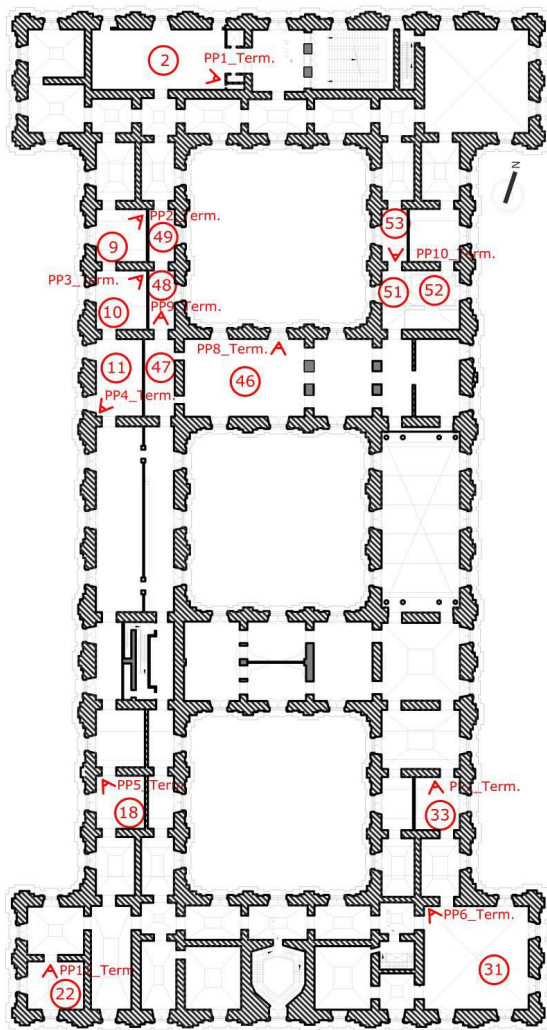
**Fig. 1:** Planimetric identification of the point of views of the infrared images together with the numbering of the rooms at the first level of the Capodimonte Museum

The infrared thermography was used to characterize the constructive typology of the vaults related to the rooms labeled in Fig. 1 with their identification number and located at the first level of the Capodimonte Museum. The case study reported in this study is referred in particular to the three couples of adjacent rooms which are characterized by a similar configuration; these are indicated with the numbers 9 and 49, 10 and 48, 11 and 47 in Fig. 1. The vaults of these rooms are a type rather common in Italy known as a schifo or mirror vault and two of them (n. 9 and 10) are painted vaults (Fig. 2); all of them are supported by structural masonry walls on three sides, while on the fourth side there is only a thin wall of about 20 cm which divides the adjacent rooms. Hence, in order to understand whether these vaults have decorative or structural function the following hypotheses were formulated on the basis of the critical analysis of the historical documentation and of the geometrical relief.

Lastly, the infrared thermography was also used to investigate the vaults related to the rooms 17, 18, 33 e 46 (Fig. 1) and also in these cases it was possible to recognize from the infrared images of the intrados surfaces the presence of the ribs of a timber structure.

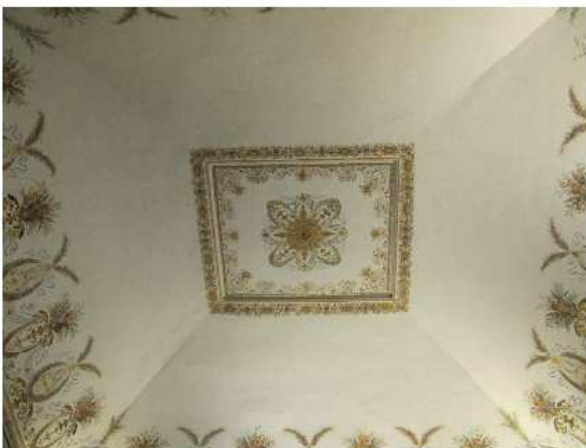
**Fig. 2:** Mirror painted vault of room n. 9

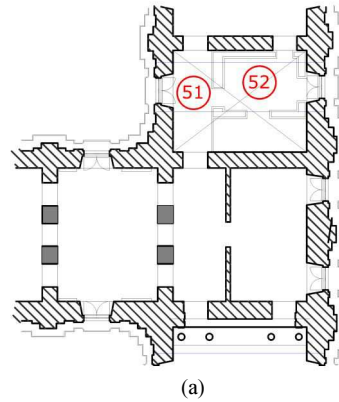
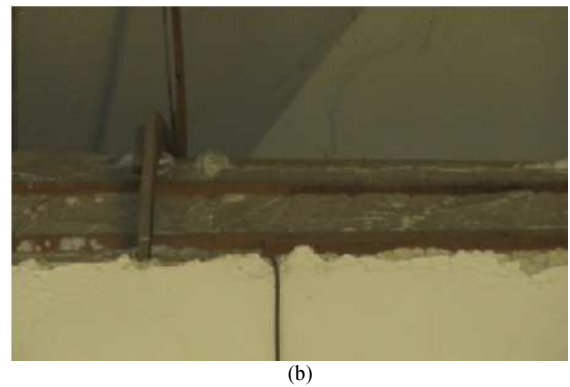
**Fig. 3:** (a) planimetric position of the "Salottino di Porcellana" (room n. 52); (b) timber vault visible from the room behind the "Salottino di Porcellana" under the original masonry vault

Another possible hypothesis is that the present visible vaults are not load-bearing, but they have a timber structure that repeats the shape of the original masonry vault. This kind of solution, on the other hand, was found out in the rooms 51 and 52 (Fig. 3) which also result from the division of a unique space; in fact, by approaching the narrow space behind the room 52 (hosting the precious "Salottino di porcellana") it was possible to discover that under the original masonry vault, still in place, there was a timber structure consisting in a series of ribs completed with a mat of plaited canes and bricks on a sheet. The height at the keystone of this latter vault is lower than that of the original one.

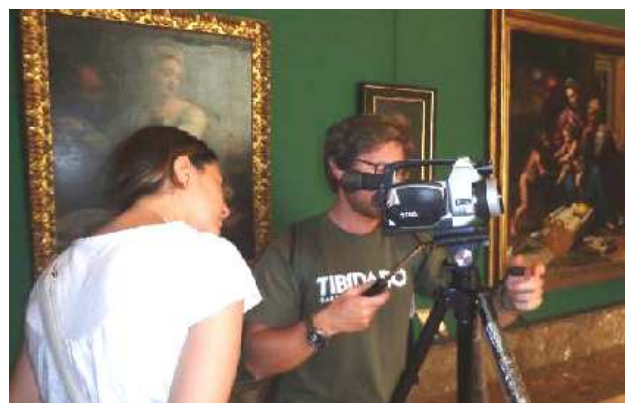
**Fig. 4:** The FLIR ThermaCAM B640 (infrared camera)

For the thermographic investigations in the Capodimonte Museum the ThermaCAM B640 model (Fig. 4) of the FLIR Company was used. The system is provided of a Focal Plane Array detector operating in the band 7.5-13  $\mu\text{m}$  and detects a temperature range from -40°C to +120°C with a measurement accuracy of  $\pm 2^\circ\text{C}$ . A passive approach of investigation was adopted by using the natural heat sources of the building as the solar radiation or the slow microclimate temperature.

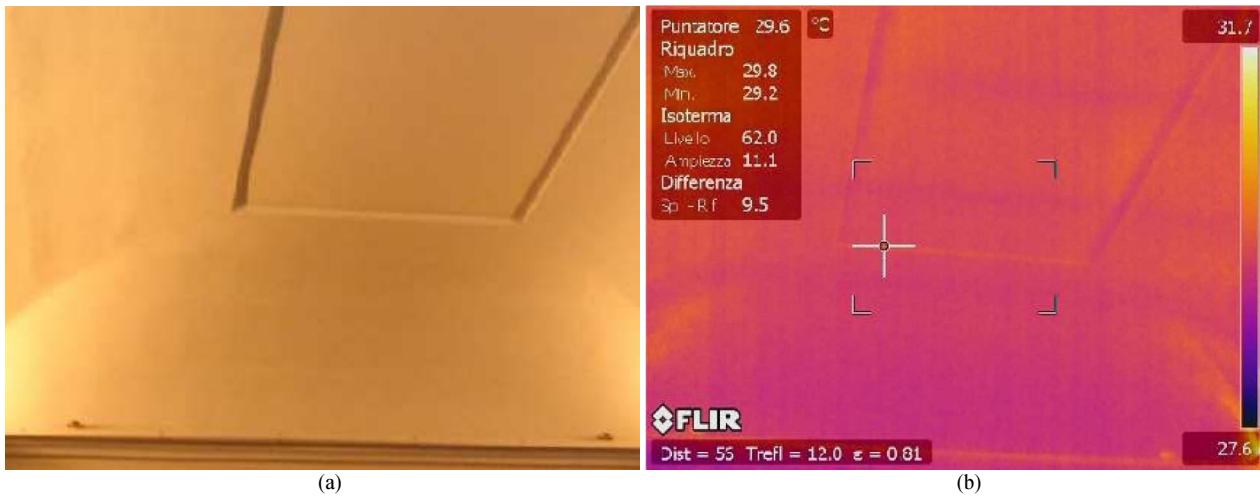
**Fig. 5:** Room n. 2. (a) view of the intrados of the vault (b) thermographic image showing the timber structure

In order to test the sensitivity of the camera, a preliminary thermographic scan of the vault covering the room n. 2 (Fig. 1) was carried out; here the presence of a timber structure (Fig. 5a and 5b) was considered very likely because the arrangement of this area together with

the Auditorium at the ground floor dates back to 1950s; in that period the pre-existing Royal Chapel, that developed with its height along two levels, was completely transformed with the creation of an intermediate floor in order to ensure the continuity of the expositive path. Then this supposition was confirmed by the thermography as shown in Fig. 5b.

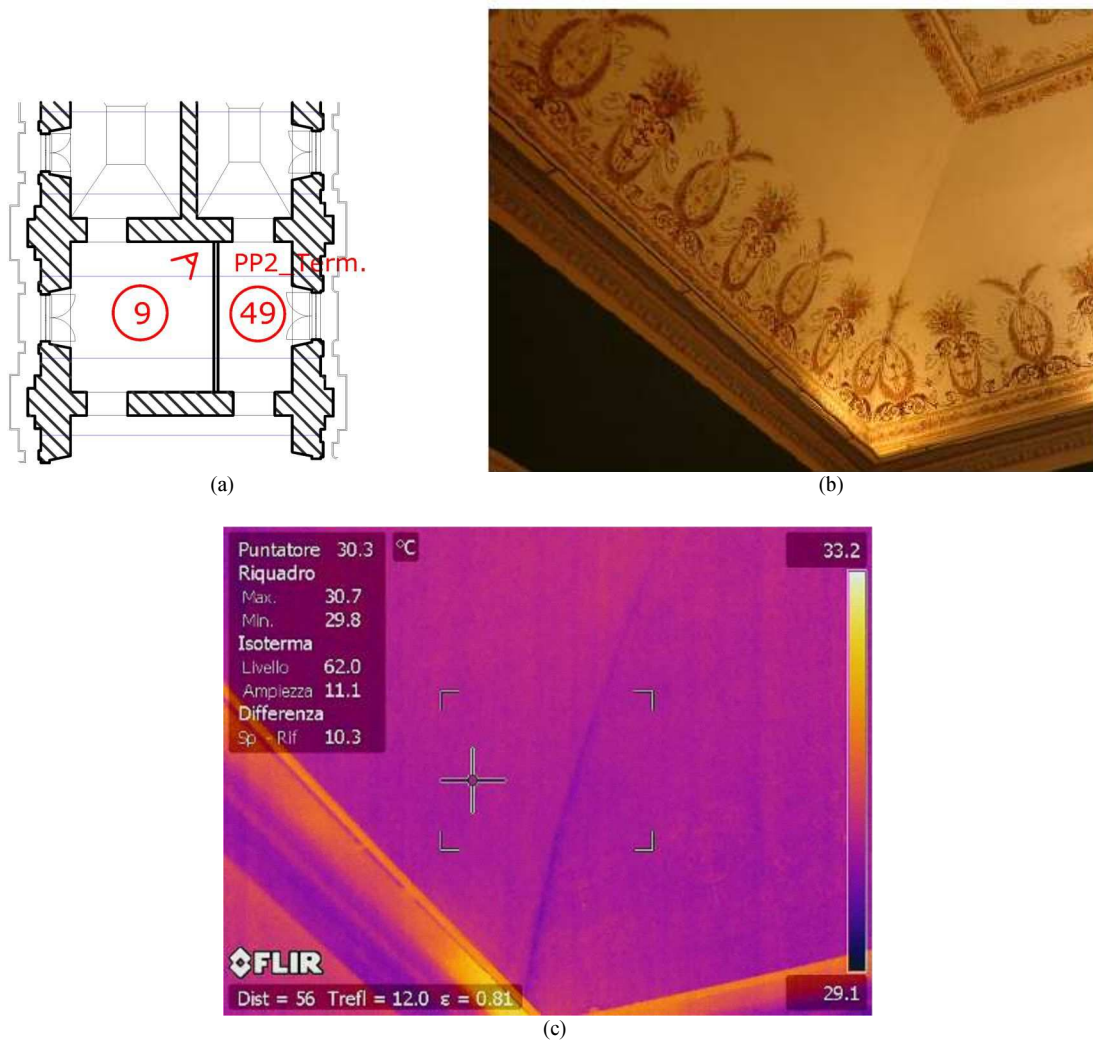
**Fig. 6:** Room n. 9. (a) planimetric localization of the point of view of the camera (b) view of the intrados of the vault (c) thermographic image

Figure 6-8 report the results of the thermographic survey related to the painted vaults covering the rooms n. 9 and 10 and to the vault of the room n. 11, respectively.

It is very likely, therefore, that the timber structures were created after the partition of the unique space covered by the original vault. About the rooms n. 9 and 10, instead, their thermographic images do not reveal the signs of the timber skeleton and this may led to suppose the presence of masonry vaults. This result, however, seems to be not consistent with the presence of a nonstructural wall on one side, as previously highlighted. Then a plausible explanation of this configuration was derived from a further typology of vault (Fig. 10) that it was possible to see from a crawl space of the Farnesian staircase. It is a no-load-bearing masonry vault, characterized by a thin thickness of bricks disposed on a sheet (20 cm average thickness). This typology could be compatible with the underneath thin wall and maybe it was related to the need of preserving the paintings on their intrados surface.

In other cases, where the overlaying load-bearing structure is not visible, the presence of structural masonry vaults was supposed on the basis of the finding of the anchors of ties, visible on the outer walls of the rooms. This is the case, indeed, of the rooms n. 9 and 10 described in the previous section.

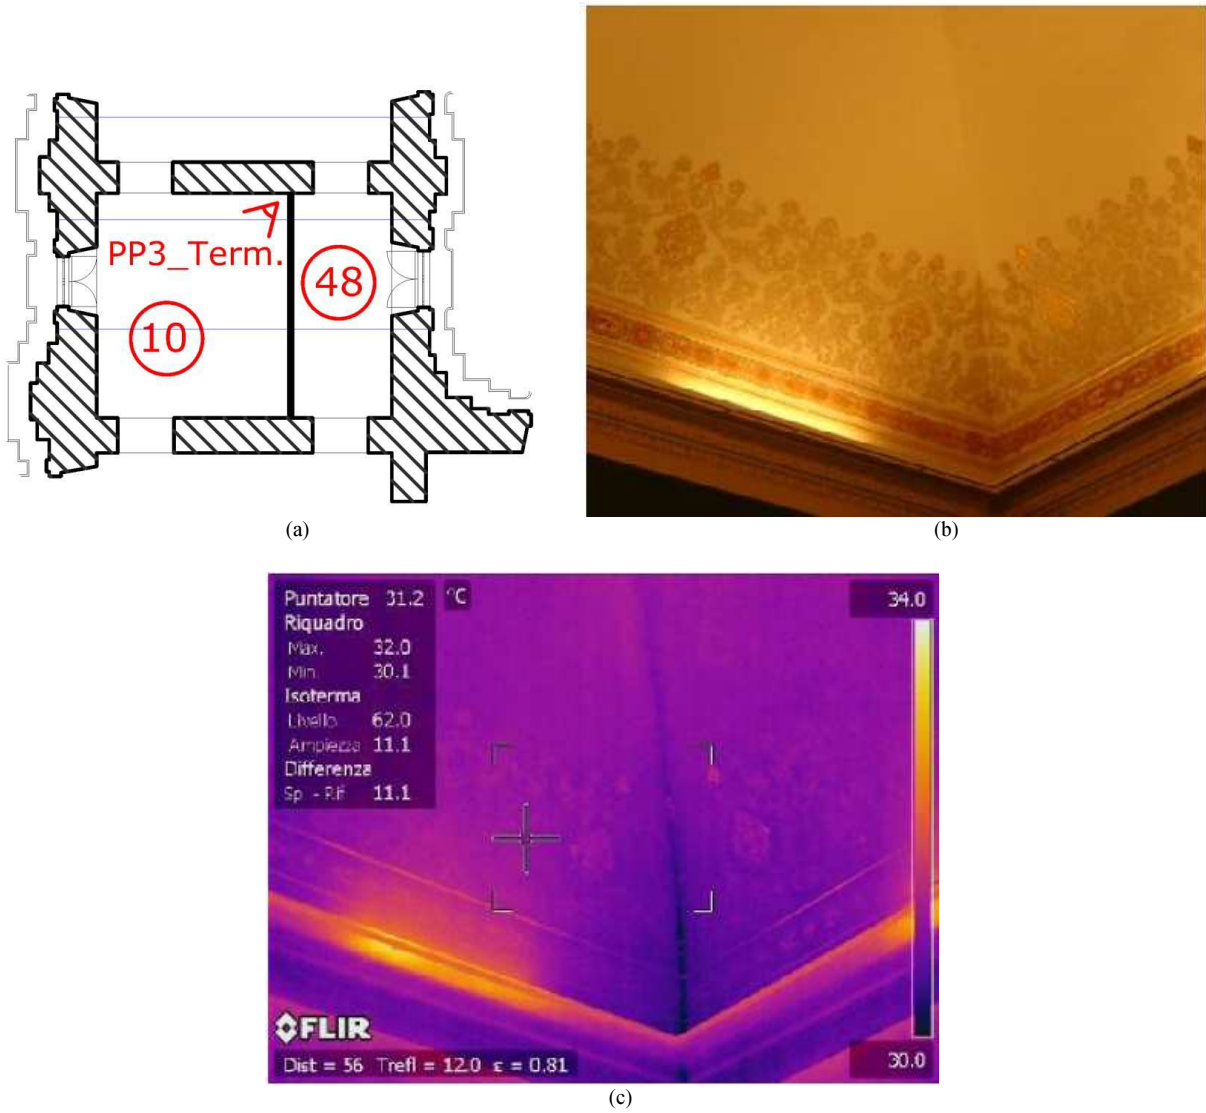
Fig. 7: Room n. 10. (a) planimetric localization of the point of view of the camera (b) view of the intrados of the vault (c) thermographic image

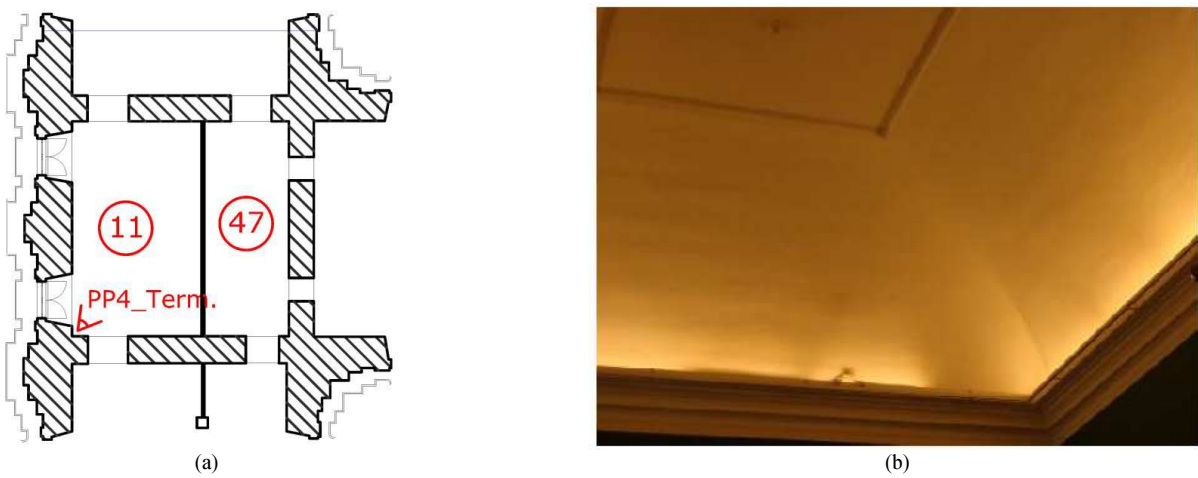
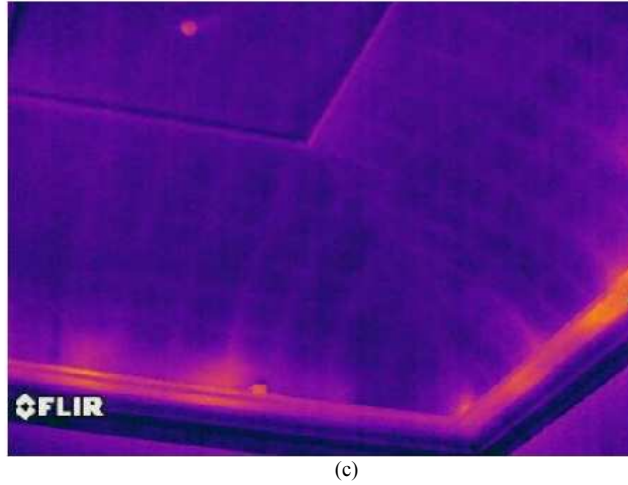
**Fig. 8:** Room n. 11. (a) planimetric localization of the point of view of the camera (b) view of the intrados of the vault (c) thermographic image

In particular, the thermographic image related to the latter vault (Fig. 8c) confirmed that it is not structural, as already suggested by the presence of a thin wall in common with the adjacent room n. 47.

Lastly, a further typology of no-load-bearing timber vaults is characterized by the presence of an overlaying plane diaphragm in r.c.; this solution is documented in particular for the rooms located in the transversal bodies around the central courtyard and dated back to the strengthening interventions carried out in the 1950s. Thus, it was supposed that a similar solution was adopted for the timber vault of the room n. 11.

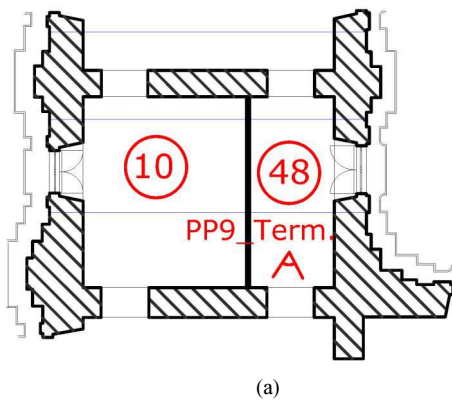
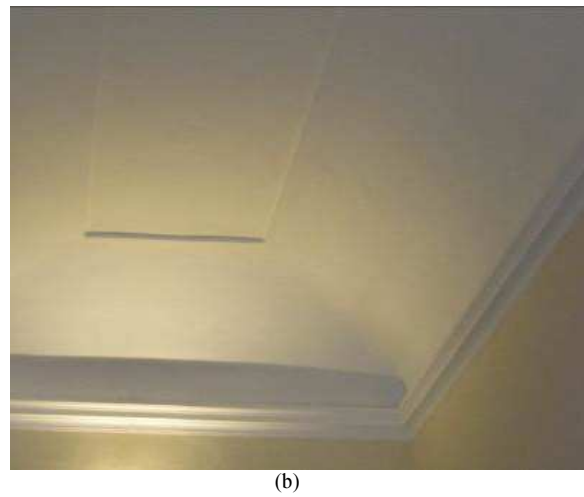
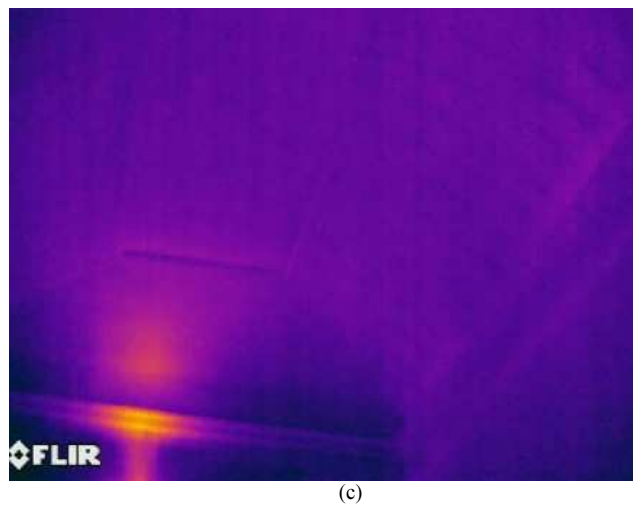
**Fig. 9:** Room n. 48. (a) planimetric localization of the point of view of the camera (b) view of the intrados of the vault (c) thermographic image

On the other hand, also the vault covering this room has a timber structure, as revealed by the thermographic image of the similar room n. 48 in Fig. 9c.

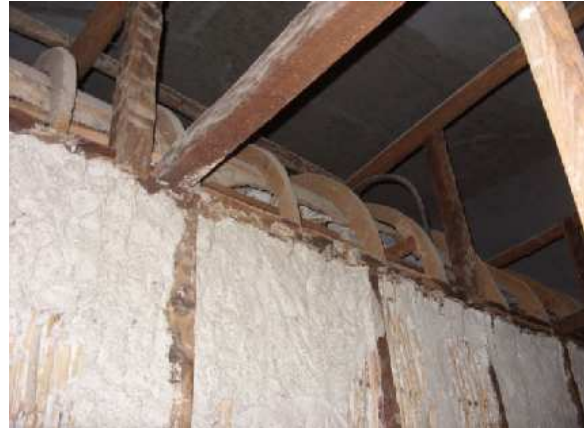
**Fig. 11:** Timber structure of the vault related to the Library
