Abnormalities in Ultrasonic (C-Scan) Images of Composite Structures: Impact Damaged Versus Hole Damaged

Abstract: This paper is about applying image processing to detect different types and levels of damage in composite structures using in C-scan images produced by ultrasonic testing. This method plays an important role as it can detect any discontinuities or flaws in the specimen. To analyze such critical image in an, automated inspection environment an image processing method that correlates Threshold values to Gradient Field values is used to extract important information from the c-scan images in order to detect abnormalities that may exist. The paper presents an improved approach to composite damage characterization using Threshold Level Variation as an input variable to Gradient Fields. Furthermore, the detailed results showed an important dependency between what can be detected and the used threshold level. At each level certain abnormalities appeared. Setting threshold value is proved to be a function of image type and quality, purpose and application.

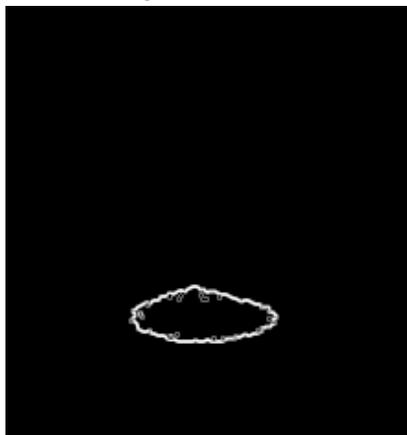
Fig. 4: Gradient of C-Scan Image: Impact Damage (0.3 Threshold)

Figures 1 to 5 show detected impact damage in C-Scan images of Woven Glass composite structure by threshold variation as a condition for conversion from RGB BW through Gray levels. The impact energy is 29 Joules delivered via a dropped vertical load. Figure 6 to 8 show other surface abnormalities when the threshold level exceeds a critical and optimized value that is used to isolate the impact damaged area from the rest of the component. Figure 9 indicates the end of ability to detect the discovered impact damage due to threshold new value.

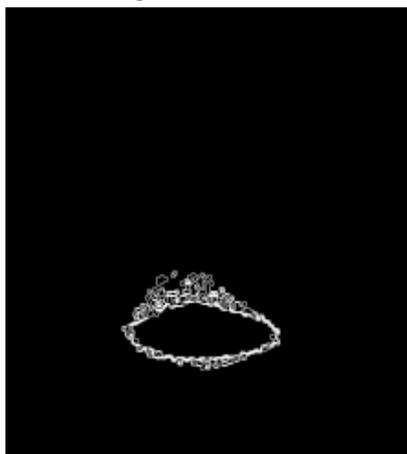
Fig. 5: Gradient of C-Scan Image: Impact Damage (0.35 Threshold)

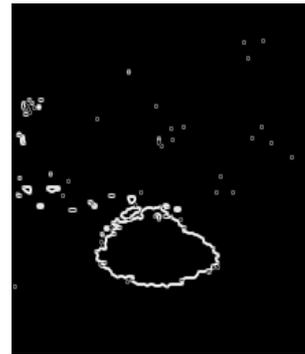
Fig. 6: Gradient of C-Scan Image: Impact Damage and Surface Abnormalities (0.4 Threshold)

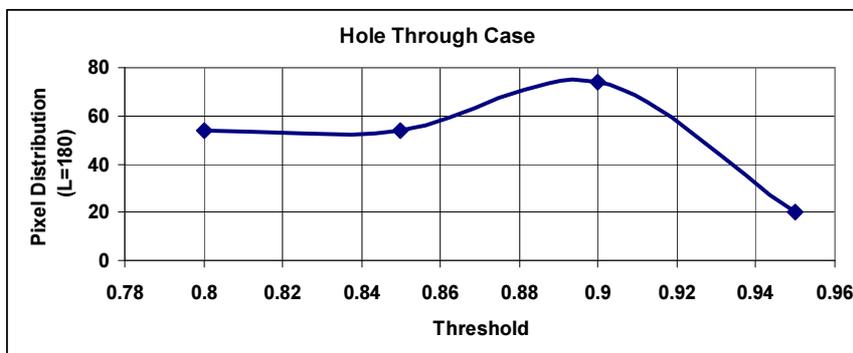
Fig. 17: Pixel distribution as a function of Threshold

Fig. 18: Pixel distribution as a function of Threshold

Fig. 19: Pixel distribution as a function of Threshold

Fig. 20: Pixel distribution as a function of Threshold

Fig. 21: Pixel distribution as a function of Threshold

Fig. 22: Pixel distribution as a function of Threshold

1. The initial Threshold level at which an impact damage is detected is 0.15, while for Drilled Hole is 0.30.
2. The final Threshold value after which no impact damage can be detected is 0.35, and for Drilled Hole is 0.95
3. The Threshold interval for impact damage is {0.15, 0.35}, while for Drilled hole, there are two intervals separated by external surface irregularities: {0.30, 0.35} and {0.55, 0.95}
4. For both components, surface abnormalities appear in the interval {0.40, 0.5}, which is consistent with the fact that they undergone same manufacturing process, and the difference is due to each one being subject to different type of external damage and handling

From the observations, characteristic matrix can be highlighted for both cases shown in Fig. 17 to 22:
