Gully Erosion Rate Assessment at the Choqazanbil Temple Using GIS Methods

Abstract: The Choqazanbil temple located at 60 km of south west of shush city in the south west of Iran. This temple with 3500 years archaism is one of the oldest historical titles in Iran. The temple position is close to the Sardarabad anticline with Neogene to Quaternary deposits. Many news about damaging of ancient buildings are reported most recently. This report shows that stream erosion can excavate the land of temple up to 2 m. The aim of this study is to determine the rate of erosion around the Choqazanbil temple using GIS methods. We select one of streams in the western templeside. Aerial Photos and satellite imagery from 1951 to 2014 was collected for use in GIS calculations. The results of this study shown that gully erosion rates take increased over time. The average rate is 18.2 m/y. In next years, this value of gully erosion can make irrecoverable damages to the Choqazanbil temple.

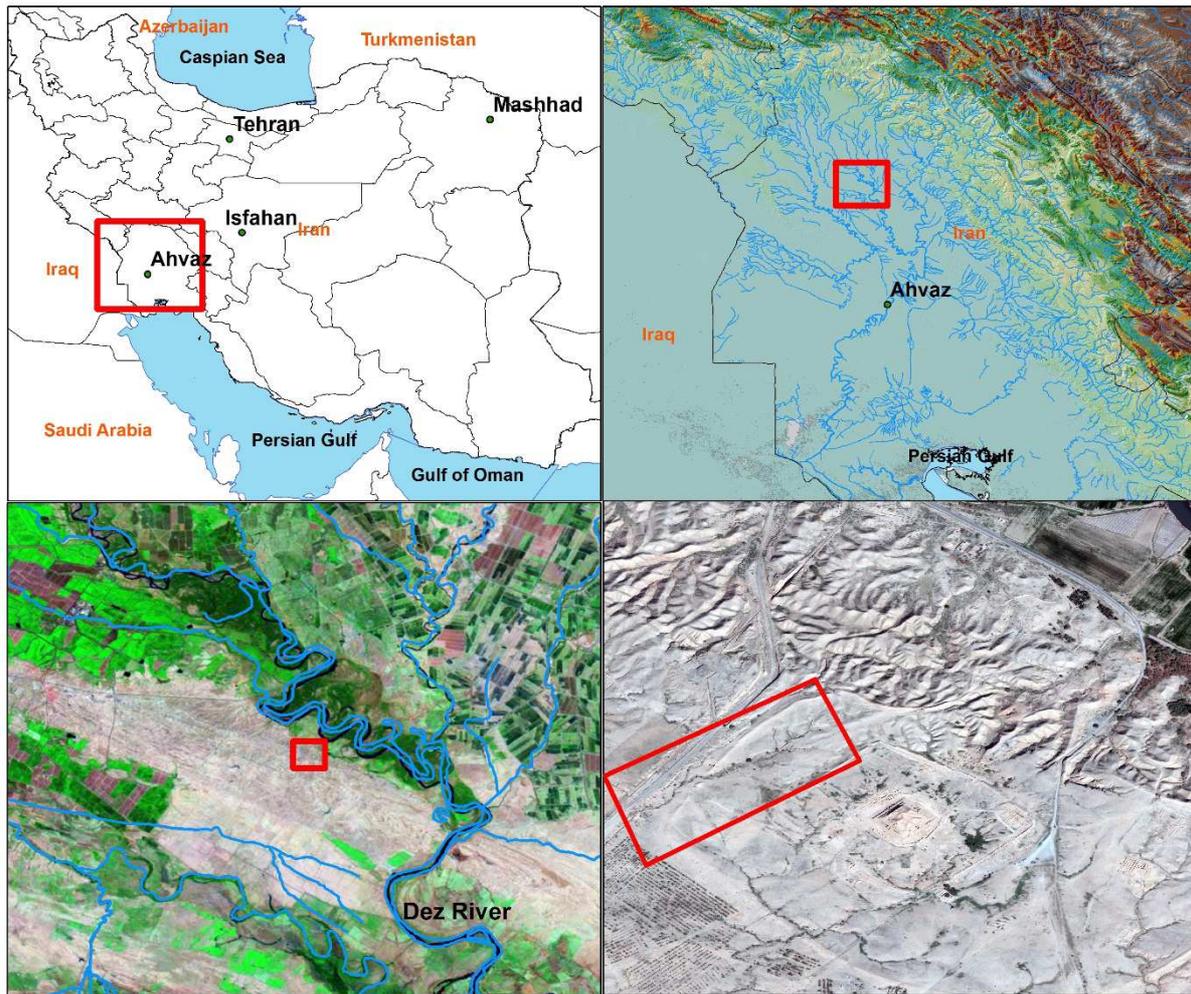
Fig. 1: Study area showed on a GIS map

a most fortified city in its time and protected using 3 circular walls with more than 20 m height Fig. 1. The wall length in order from outside to inside is 1200, 450 and 130 m (Mahmoudi *et al.*, 2015; NAT, 2011). Temple area drains with several streams that its twigs are located near this ancient place. Gully erosion caused by atmospheric agents (Albert *et al.*, 2006), excavated the stream bed and made deepening and expansion drainages in the temple area Fig. 2.

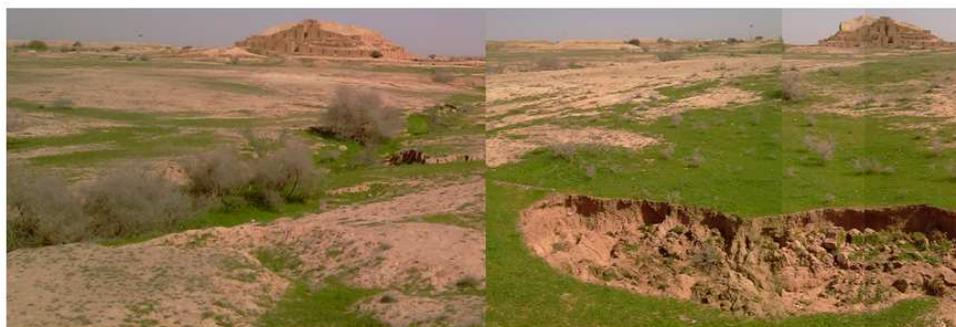
Fig. 2: Sample of Gully erosion in the Choqazanbil temple area of selected stream

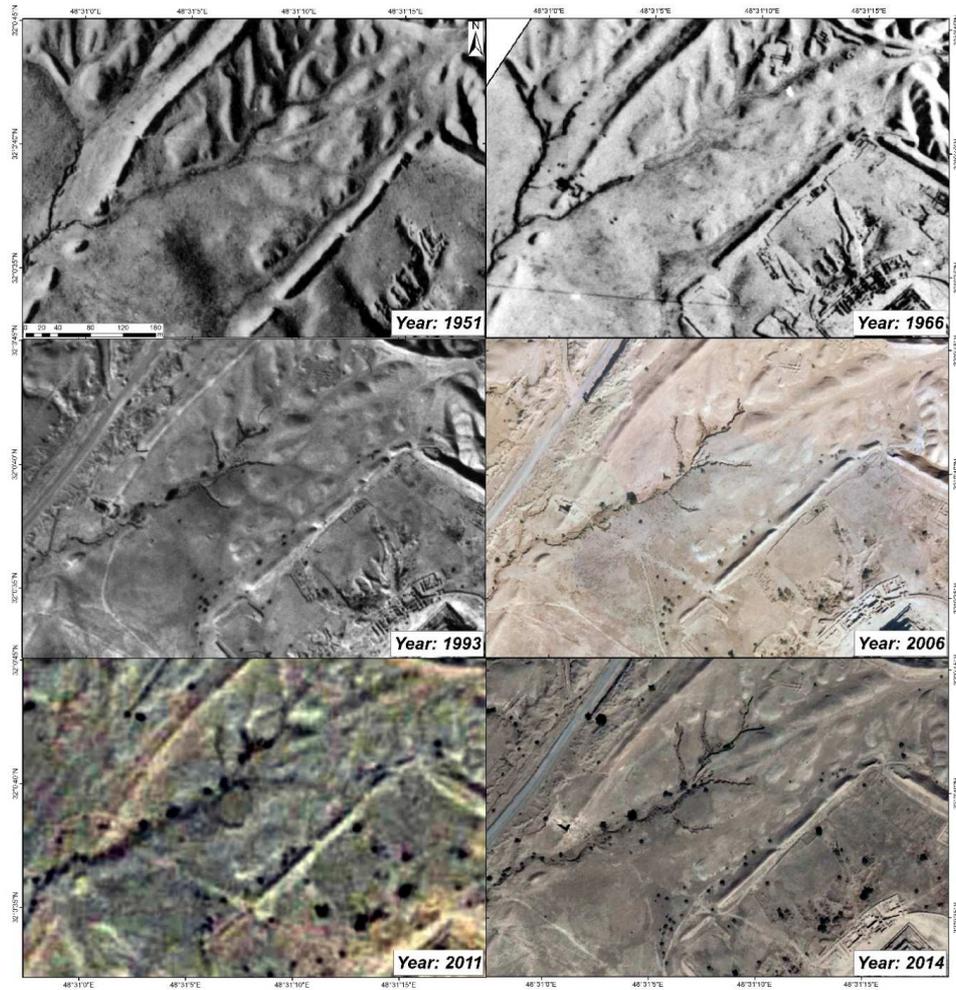
Fig. 3: Gully erosion shown in Aerial Photograph from 1951 to 2014

As it mentioned, we used Aerial photographs that are taken in 1951, 1966, 1993, 2006, 2011 and 2014. These images covered 63 years of erosion time. After digitizing the photographs, trend of gullies developments was

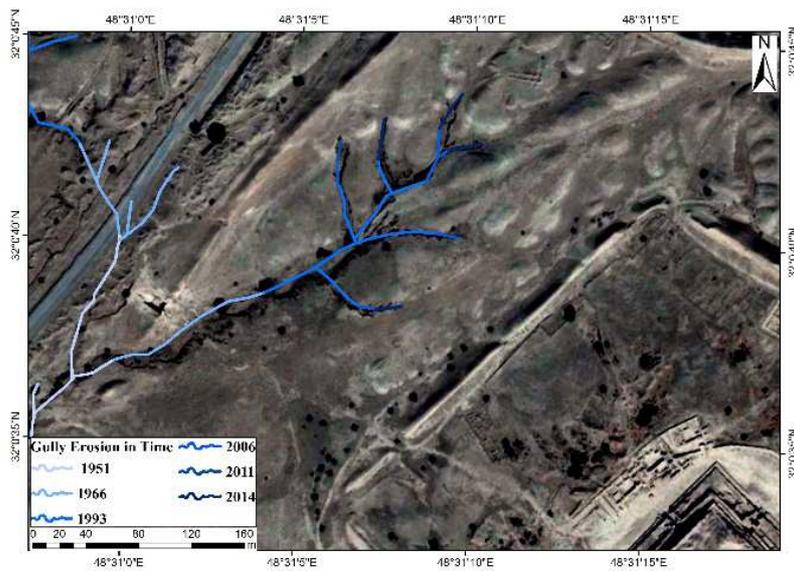
Fig. 4: The gully erosion trend shown by green tone colors from 1951 to 2014

founded Fig. 4. The results of GIS measurements are in Table 1. Figure 5 was made for better understanding of Table 1 data's. Base on this data's, the gully erosion rate take increase by time. The minimum value is 5.5 m/y that is for 1951 and the maximum value (29) calculated for 2014. The average gully erosion rate is 18.2 m/y.

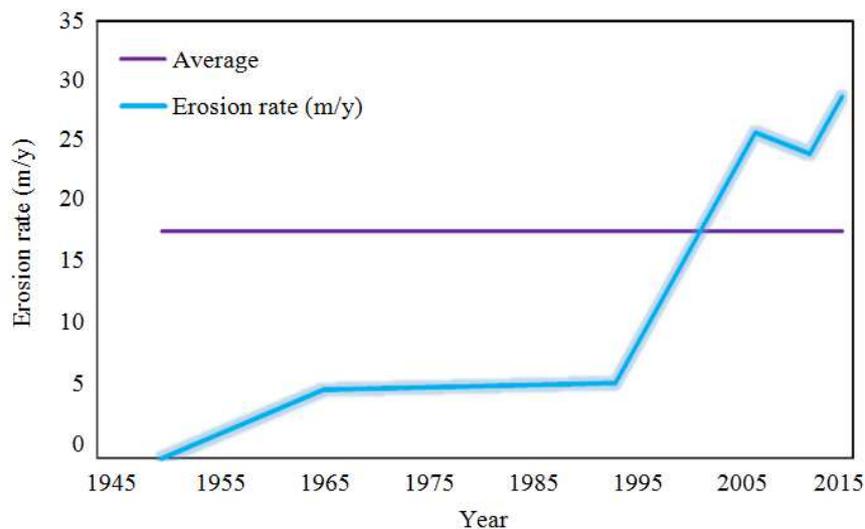
Fig. 5: Chart of erosion rate change

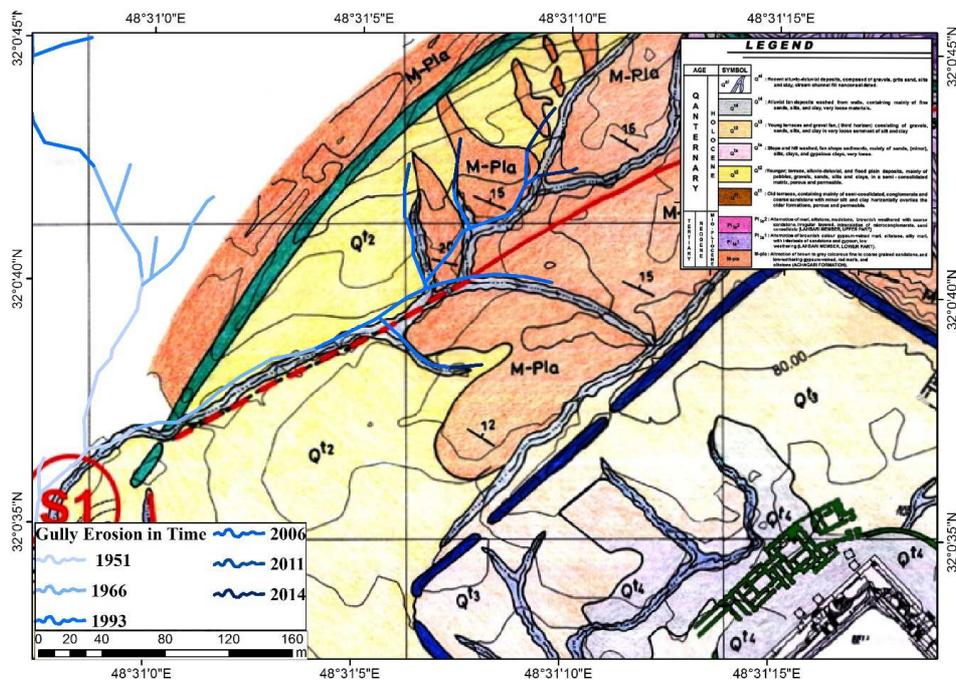
Fig. 6: Geological map of Choqazanbil temple (Jarahi, 2013)

The erosion rate from 1965 to 1993, is about 5.5 (for 28 years). But from 1993 to 2006 (for 13 years), this value has increased five times. Changing at the gully erosion rate caused by two main parameters; climate changing and geological units change. In the short period (about 3000 years), the climate can't change. To check the geological parameter, we used the geology map Fig. 6 of Choqazanbil temple (Jarahi, 2013; Perry and Setudehnia, 1967). As it is shown in Fig. 6, before 1993 the activation of gully erosion take location in Q¹² deposits with more than 200 m thickens. The constituent materials of this unit include moderate compacted gravel, sand and silt with low permeability. After 1993, the gully continues its erosion in M-Pla units. Deposits of this unit are alternately of marl and gypsum-bearing sandstone, with a poor degree of compaction. Therefore, change in geological unit can be the main effective parameters in association with increasing gully erosion rate.
