Scanning Electron Microscopic Evaluation of Self-Compacting Concrete Spalling at Elevated Temperatures

¹Mahmoud B. Alhasanat, ¹Arabi N. Al Qadi, ²Omar A. Al Khashman and ¹Ahmad Dahamsheh

¹Depatment of Civil Engineering, AlHussien Bin Tala Univ., Ma'an, Box 20, Jordan ²Depatment of Environmental Engineering, AlHussien Bin Tala Univ., Ma'an, Box 20, Jordan

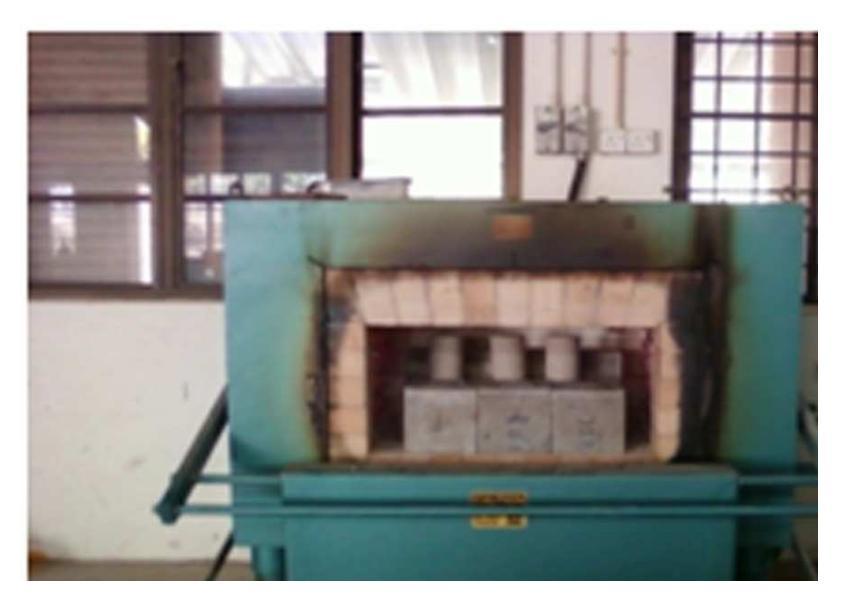
Fig. 1. The specimens in the furnace

The specimens were placed in an electrical box furnace of chamber size 600×300×300 mm (with a maximum temperature of 1200°C [2192°F]) and a heating rate of 5-10°C (50°F) per minute at elevated temperature. Concrete specimens were taken out from the curing environment at 89 days and kept under dry conditions in the laboratory for one day before being exposed to fire test. The temperature was kept at 200°C (392°F), 400°C (752°F) and 600°C (1112°F), each maintained for 4 h. The temperature was raised slowly until the required temperature was reached. The temperature was then maintained constant for 4 h. The specimens were then removed out of the oven, cooled down to room temperature by keeping them at room temperature, and exposing them to air circulation by a fan, then they was weighed and coded. Figure 1 shows the specimens in the furnace.

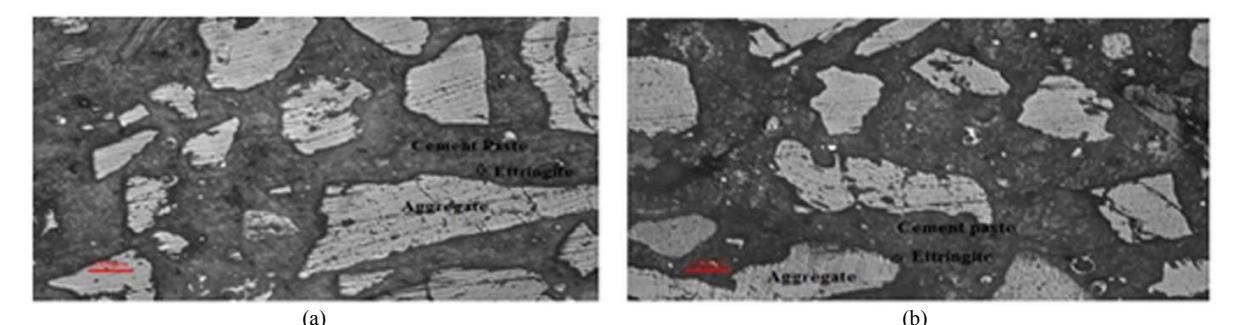
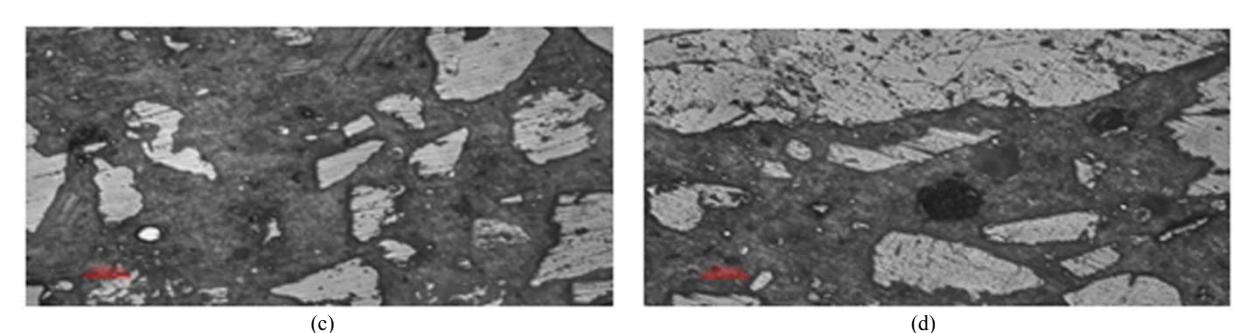
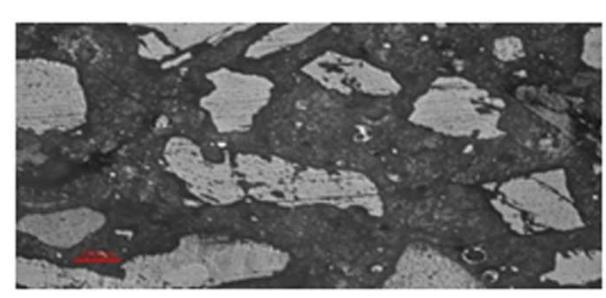
Fig. 2. Scanning electron microscopy of plain SCC from (a) to (e), (a) Plain SCC at Room Temperature (27°C), (b) Plain SCC at 600°C, (c) Plain SCC at room temperature (27°C), (d) 4 h, 400°C and plain SCC, (e) 4 h, 600°C and plain SCC

The micro structure of SCC mixtures was tested on a small specimen of concrete with a diameter of approximately 25 mm (linch) and a thickness of about 4 mm (0.16 inch), and the specimen had been cut in order to be tested by SEM. The specimens were previously coated with a very thin layer of gold to prevent charge built-up on the surface after being subjected to elevated temperature (Fig. 2).

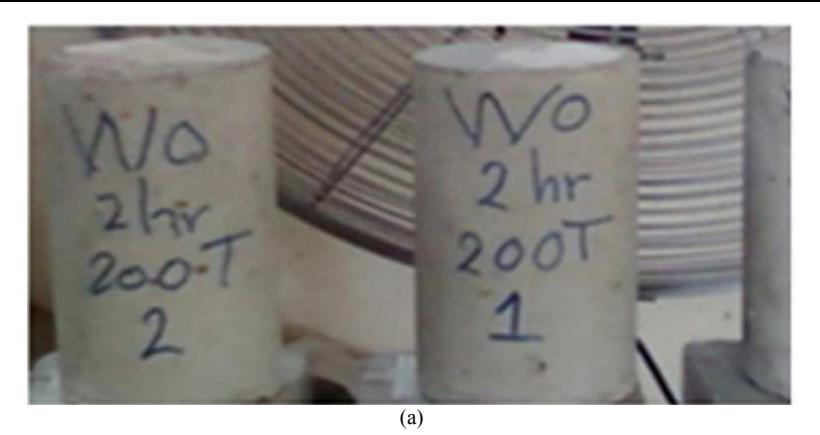
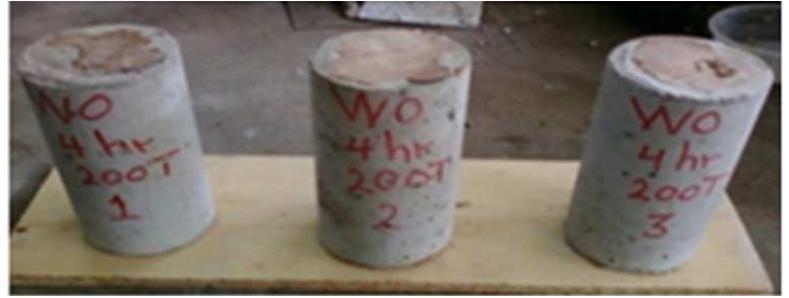
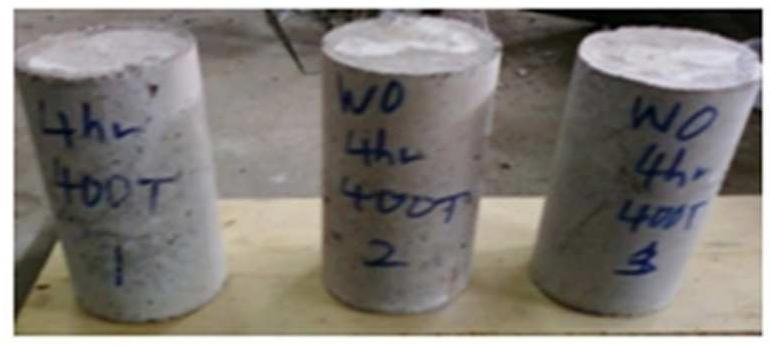
Fig. 3. Plain SCC mixtures specimens, (a) 2 h, 200°C and plain SCC, no explosive spalling, (b) 4 h, 200°C and plain SCC, no explosive spalling, (c) 4 h, 400°C and plain SCC, no explosive spalling

Figure 3 shows specimens subjected to fire test. In Fig. 3a, no spalling occurs although there were specimens of plain SCC, but there were small cracks on the surface of the specimens when the temperature was $200^{\circ}C$ ($392^{\circ}F$) for a heating period of 2 h.

Also in Fig. 3b, specimens of plain SCC showed more cracks appeared on the surface when the time of exposure was increased to 4 h. In Fig. 3c, plain SCC specimens showed small cracks appear and no explosive spalling occurred with peak temperature maintained at $400^{\circ}C$ (752°F) for 4 h.

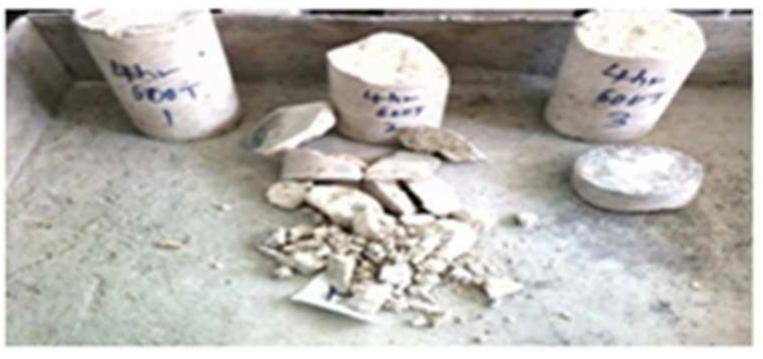
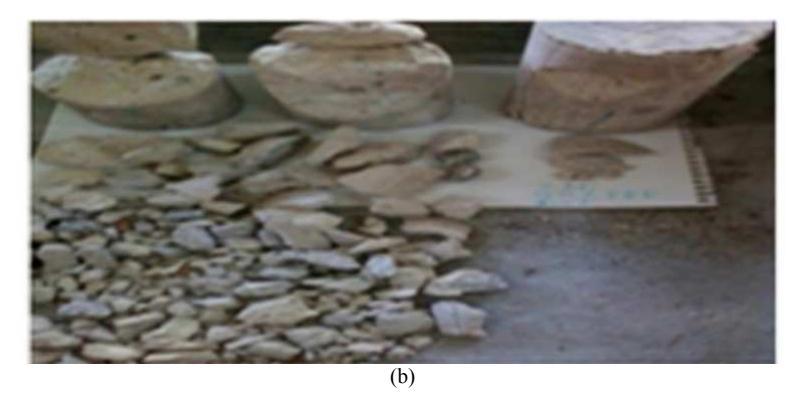
Fig. 4. Plain SCC Mixtures with Explosive Spalling Clear, (a) 4 h, 600°C, plain SCC explosive spalling clear, (b)2 h, 600°C, plain SCC, explosive spalling clear

Figure 4 shows some of the specimens after heating with peak temperature maintained at 600°C (1112°F) for 2 and 4 h. In Fig. 4a, the most common type of damage was in specimen number 2, as nearly everything from the middle to the upper of the specimens were exploded; in specimen number 3, explosive spalling took place in the upper part as one big piece; and specimen number 1 did not spall. In other modes, Fig. 4b nearly behaved in the same way and showed the same trend because they were tested under the same temperature, which was 600°C (1112°F). All these tests were conducted on plain SCC specimens at 600°C (1112°F) with an exposure time of 2 and 4 h.

If the spalling degree = 0.3, then 30% of the specimen mass was lost as a direct result of spalling. For the test on specimens with plain SCC and a 2 h exposure time and at 600° C (1112°F), the spalling was measured as in Equation 1 as follows:

Spalling degree =
$$\frac{0.24}{1.58} = 0.15$$

This means that 15% of the cylinder specimens are lost as a direct result of spalling. Also, for a test on cylinder specimen at plain SCC fibers over a 4 h exposure time and at 600°C (1112°F), the spalling is measured as follows:

Spalling degree =
$$\frac{0.5}{1.6} = 0.31$$

This means that 31% of the cylinder specimens are lost as a direct result of spalling.

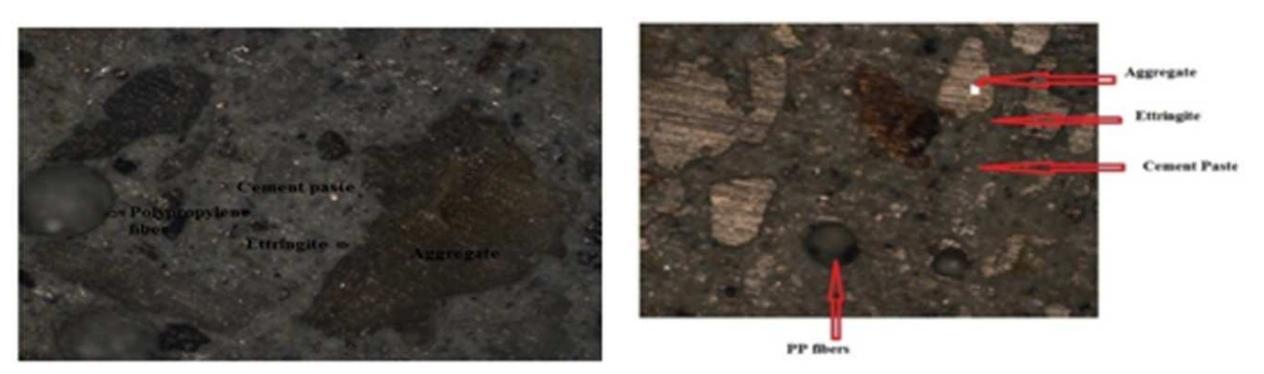
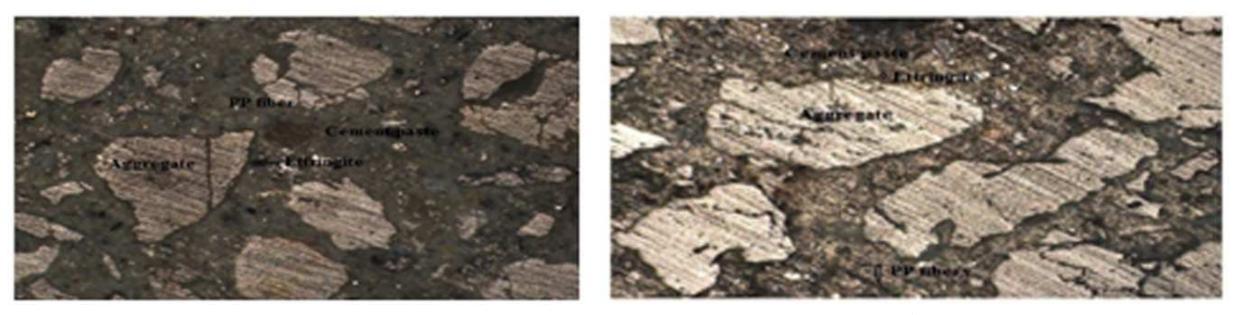
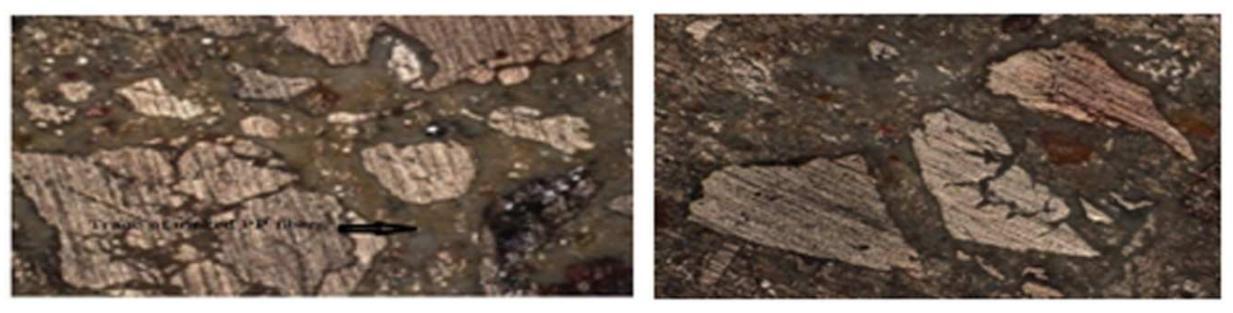
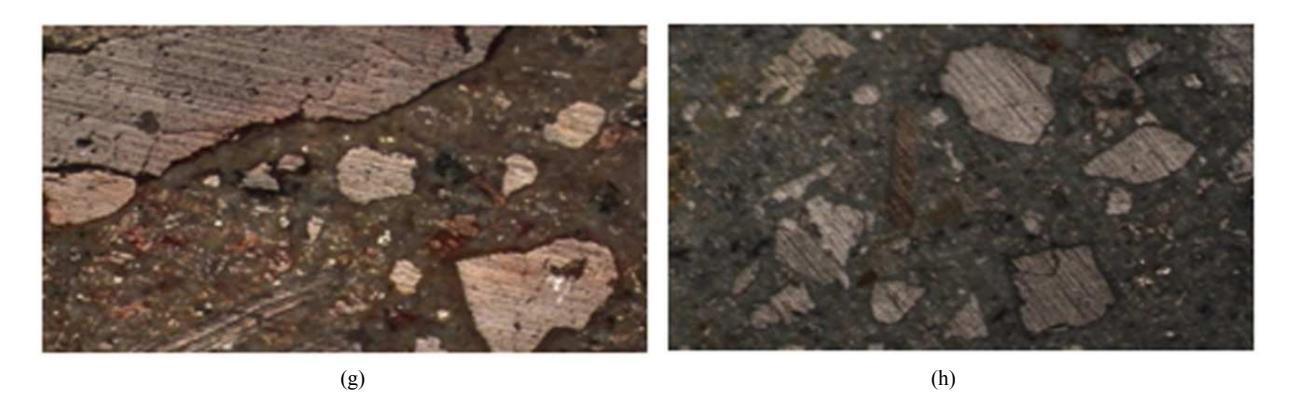
Fig. 5. Scanning Electron Microscopy of SCC from (a) to (h), (a) 2 h, 200°C and 0.10% PP, (b) 2 h, 200°C and 0.15% PP, (c) 2 h, 400°C and 0.05% PP, (d) 2 h, 400°C and 0.10% PP, (e) 2 h, 600°C, 0.05% PP, (f) 2 h, 400°C and 0.15% PP, (g) 2 h, 600°C and 0.15% PP, (h) 4 h, 200°C and 0.05% PP

Figure 5a-h show the matrix SCC with PP fibers and granite aggregate adherence determined under scanning through electronic microscope for 0.0, 0.05, 0.10 and 0.15% of PP fibers by volume of SCC mixture.

Figure 5a to h indicates that at 2 and 4 h exposure times and with the increase in temperature to 200°C ($392^{\circ}F$), 400°C ($752^{\circ}F$), 600°C ($1112^{\circ}F$) and at 200°C ($392^{\circ}F$) to 300°C ($572^{\circ}F$), the interlayer C-S-H water and some of the chemically combined water from the C-S-H and sulphoaluminate hydrates would also be lost. In addition, further dehydration of the cement paste due to decomposition of calcium hydroxide begins at about 500°C ($932^{\circ}F$) to 600°C ($1112^{\circ}F$).

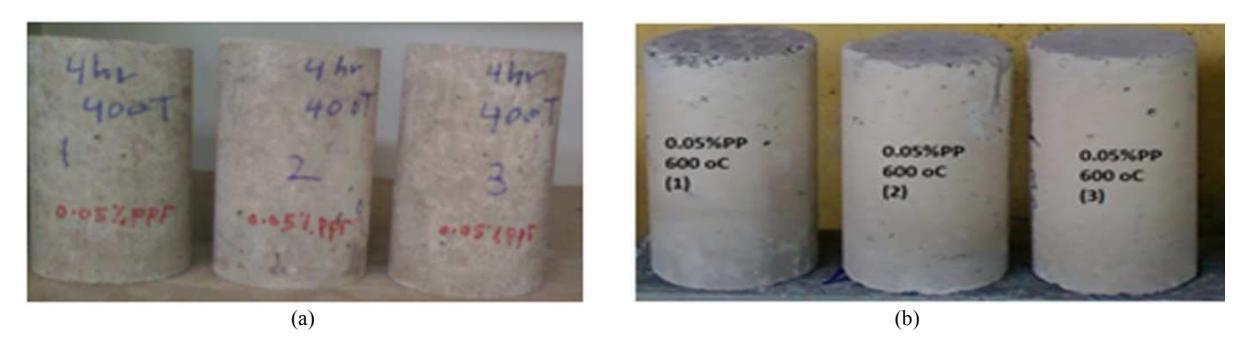
Fig. 6. SCC with addition of PP fibers no spalling clear (a) 0.05% PP fibers, 4 h and 400°C, (b) 0.05% PP fibers, 4 h and 600°C

Figure 6a and b shows that addition of PP fibers could be used to mitigate spalling. As seen in Fig. 6a, the SCC with 0.05% of PP fibers with peak temperature maintained at 400°C (752°F) for 4 h no spalling occurred. Furthermore, in Fig. 6b, as the peak temperature was maintained at 600°C (1112°F) for 4 h time of exposure, no explosive spalling occurred.
