# In-Plane Behavior of Infills using Glass Fiber Shear Connectors in Textile Reinforced Mortar (TRM) Technique

**Abstract:** Masonry has a widespread use in the construction of the buildings even in reinforced concrete or steel frames. Past earthquakes have demonstrated the vulnerability of masonry infills resulted in the human life losses and economic costs. Recently innovative strengthening techniques such as Textile Reinforced Mortar technique (TRM) is used for enhancing the seismic response of the infills. Different procedures were suggested to enhance the bond between rendering mortar of the TRM technique and infilled frame to prevent its detachment. In this study commercial glass fiber shear connectors were used for connecting the TRM layer to the infilled frame and their response were investigated by testing the samples in the in-plane direction. The quasi static in-plane test was performed cyclically on two specimens; one without strengthening layer and another strengthened with commercial textile meshes. The results showed that TRM technique enhances the in-plane response of the infilled frames but the effectiveness of the shear connectors could be improved using proper m

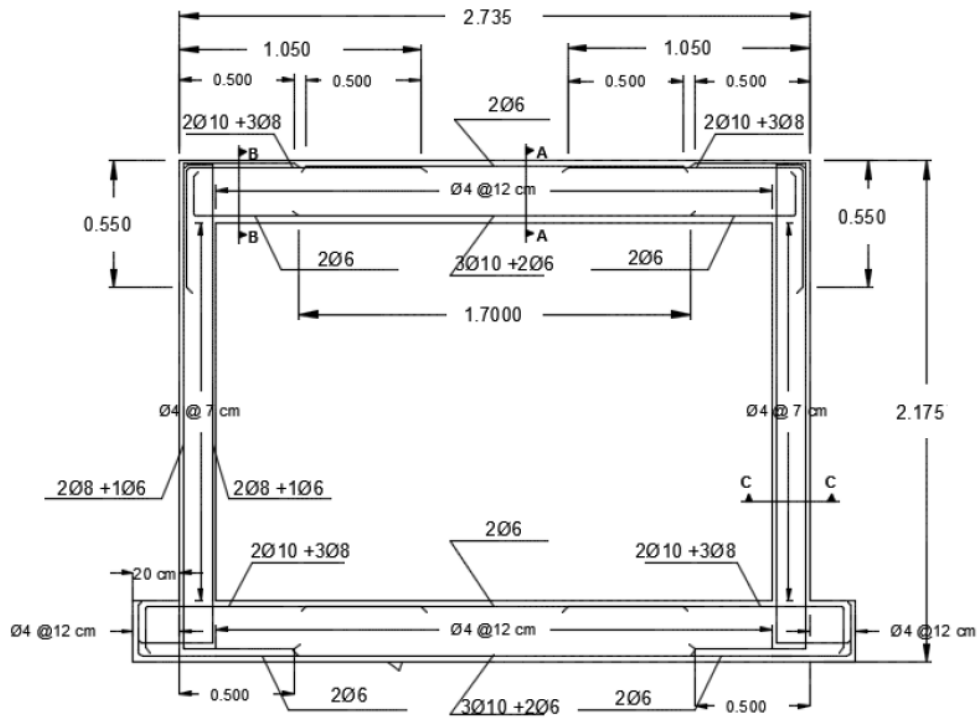
**Fig. 1:** Geometry and reinforcement scheme of the reduced scale rc frame (dimensions in meter)

An overview of the scaled reinforcement scheme of the rc frame and of the cross sections of columns and beams are shown in Fig. 1 and 2.

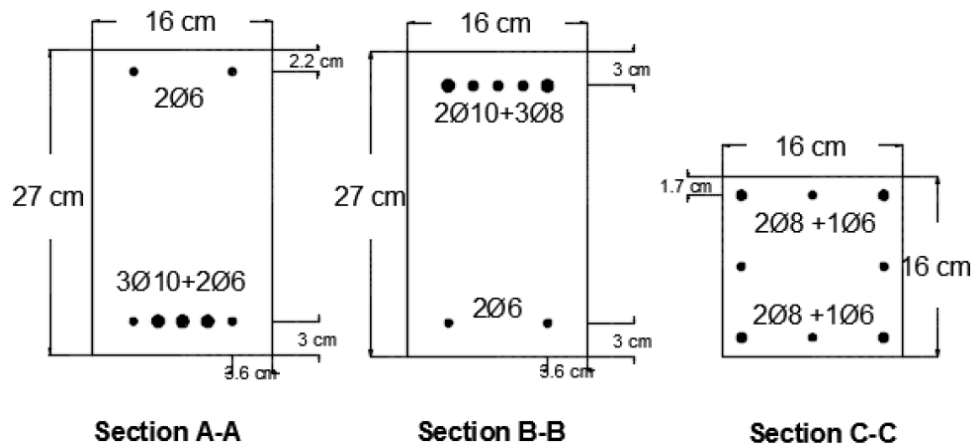
**Fig. 2:** Cross-sections of columns and beams in reduced scale rc frames

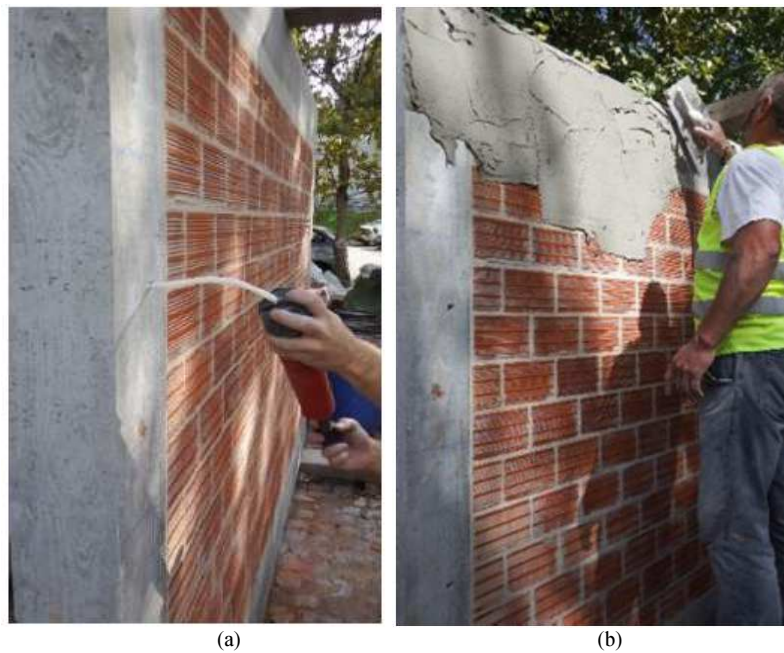
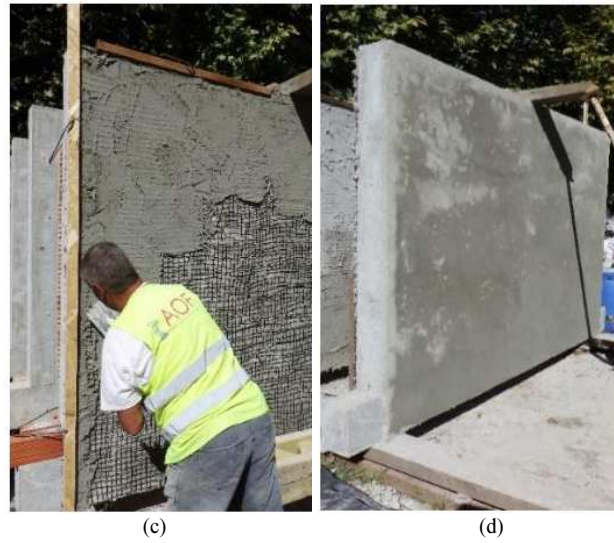
**Fig. 5:** Application of the reinforced rendering; (a) drilling the pilot holes (b) applying the first layer of mortar (c) positioning of the textile mesh and application of the second layer of mortar; (d) final aspect after rendering

Additionally, L-shaped shear connectors were used to avoid any detachment of the rendering mortar from rc frame and masonry infill (Fig. 4a). Following steps were used to apply the rendering mortar to the specimens: In the first step the pilot holes were defined as shown in (Fig. 4a) to place the shear connectors in the specimens. In the second phase the holes were drilled and cleaned and then the plastic row plugs shown in Fig. 4b were inserted in the holes (Fig. 5a). In the third step, First thin layer of about 5 mm of mortar was applied on the specimens (Fig. 5b). In the fourth step, chemical anchor was injected into the holes and L-shaped glass fiber connectors were inserted into them. Then in the fifth step the textile mesh was positioned on the first layer of mortar and finally in the last step the second layer of mortar was applied and rectified, see (Fig. 5c and d). The total thickness of the rendering was measured as approximately 20 mm in all the specimens. The application of the rendering in two successive layers enables the involvement of the textile mesh by the mortar and also adequate development of the adherence between them.

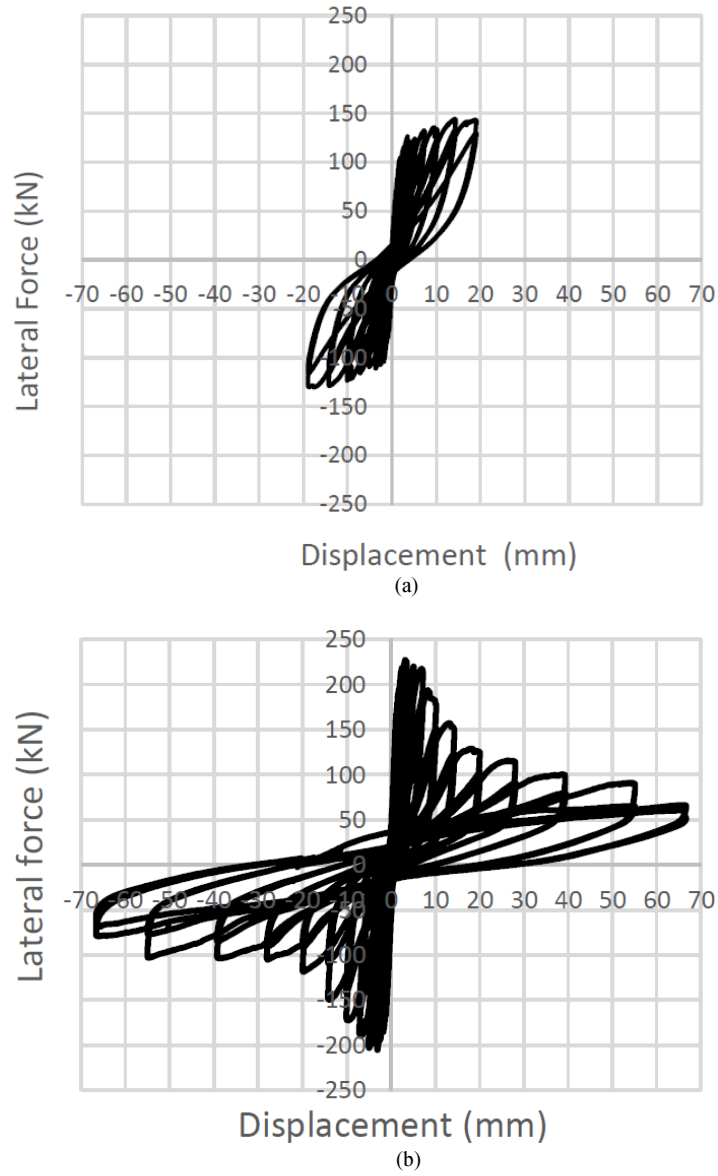
**Fig. 10:** Force-displacement diagram; (a) SIF-I(1%) (b) SIF(DTRM)-I

The lateral force-displacement diagrams obtained for unstrengthened and strengthened specimens are shown in Fig. 10. It is clear that the strengthened specimen demonstrates better response in terms of initial stiffness and lateral strength. The increase in initial stiffness and lateral strength was reported as 43 and 58% in positive direction and 23 and 57% in negative direction. As it was mentioned previously, the unstrengthened specimen was tested until lateral drift of 1% to be used in another testing campaign investigating the effect of prior in-plane damage on out-of-plane response. The positive direction is considered as the direction that the hydraulic actuator pushes the specimen whereas the negative direction is considered as the direction that the actuator pulls the specimen through two plates that were connected with two thick steel rods. The force-displacement diagrams are characterized by an initial linear behavior corresponding to the elastic behavior of the structure. After the onset of cracking, the nonlinear behavior is visible both through the nonlinearity of the force-displacement envelop and through the higher hysteresis corresponding to the development of damage and dissipation of energy.

The post-peak behavior is characterized by a progressive but smooth reduction on the lateral strength and stiffness, meaning that the damage is controlled and progressive.

It is clear that the strengthened specimen demonstrates better response in terms of initial stiffness and lateral strength. The increase in initial stiffness and lateral strength was reported as 43 and 58% in positive direction and 23 and 57% in negative direction.

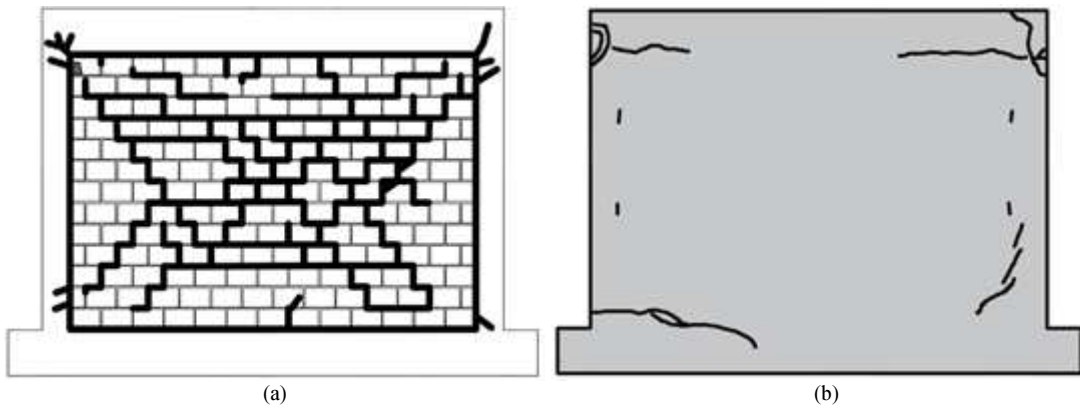
**Fig. 11:** Final cracking pattern of the (a) specimen SIF-I(1%)-B; (b) specimen SIF(DTRM)-I

The final cracking pattern developed in the cavity walls during the cyclic in-plane tests are shown in Fig. 11.

In the case of cracking pattern of unstrengthened infilled frame, it is characterized by: (1) separation of the infill from its rc frame. This separation starts from very early stages of lateral deformation; (2) diagonal cracking along the unit-mortar interfaces. After the separation between the masonry infill and the rc frame, the diagonal strut forms and diagonal cracking develops; (3) crushing of brick units adjacent to the top interface between the rc frame and masonry infill. It is observed that the cracking of the rc columns is more controlled in case of presence of the masonry infill. It is clear that the specimen (SIF-I(1%)-B) presented more intense damage as most of the brick-mortar interfaces were cracked along with the cracking of RC frame in connection points of columns and beams. It is important to note that the cracking shown in Fig. 11 is regarding to the external leaf but the cracking in the internal leaf is very similar, indicating that both leaves are effective in the resistance to the in-plane loading. This similar behavior exhibited by the internal and external leaves is also confirmed by the average shear distortion calculated for both internal and external leaves that presented in Fig. 12.

For the cracking pattern of the specimen strengthened with bi-directional mesh composed of braided composite rods, only few cracks were developed in the reinforced mortar layer. Horizontal cracking was visible along the infill-rc frame interfaces. Some small cracks were also observed in the areas where the shear connectors were totally failed. The results showed that at lateral drift of 0.07% in both directions the strengthening mortar layers started to detach from the rc frame. This was observed from the results of LVDTs placed to measure eventual debonding of the mortar layer, Fig. 13. Based on this results, it seems that alternative shear connectors should be used in the rc fame as during the test brittle failure of the shear connectors were observed.

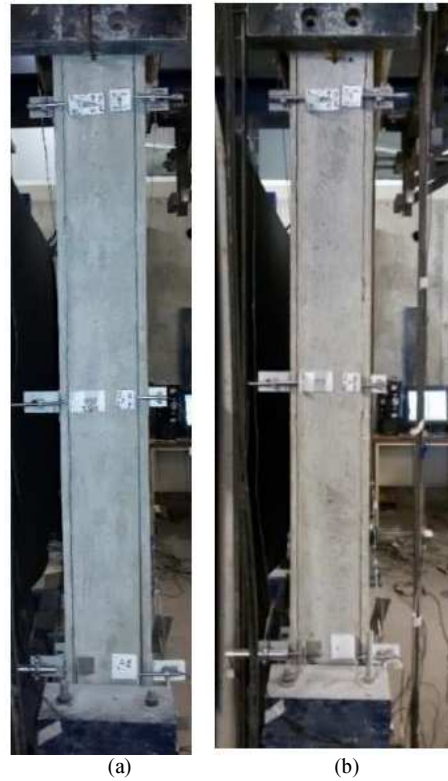
**Fig. 13:** Detachment of the reinforced mortar layer from the rc frame (a) specimen strengthened with commercial mesh at lateral drift of 0.27% (b) (a) specimen strengthened with developed mesh at lateral specimen strengthened with developed mesh at lateral

To note that shear connectors used for masonry infills did not face with any failure during the test. Investigations on the results of LVDTs installed on the height of the samples to measure the possible debonding of the rendering mortar from rc frame demonstrated that the detachment along the height of the specimens is similar. The appropriate preparation of concrete surface before applying the rendering mortar according to what is pointed out by Escrig *et al.* (2015) can be assumed as an alternative solution for enhancing the adherence of the rendering mortar to the reinforced concrete frame.

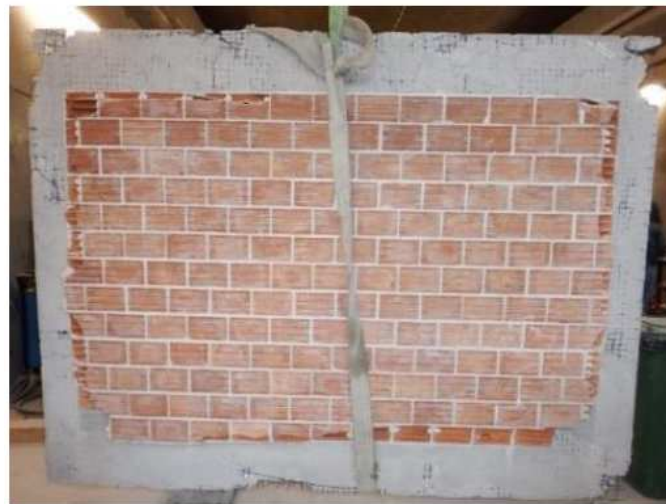
**Fig. 14:** View of the crushing of bricks of the infill after removing some parts of the retrofitting layer in specimen SIF(DTRM)-I

After the test, the reinforced mortar layer was removed mechanically to obtain information about the damage of the brick infill. It was seen that the masonry units crushed along the rc frame-infill interfaces, Fig. 14.

This could be related to the higher concentration of compressive stresses along the edge of the brick infill. It was also seen that no additional cracks were formed in the brick infill apart from the crushing in the bricks adjacent to the rc frame, indicating that the reinforced mortar layer acts as a damage controller by limiting the development of cracks in the brick infill. The crushing of the bricks along the interface is very similar between both strengthened specimens, even if it appears to be more significant in the specimen strengthened with the commercial textile mesh.
